City of Hamilton

# Roadside Safety Assessment

Red Hill Valley Parkway

Final Report  
January 2019

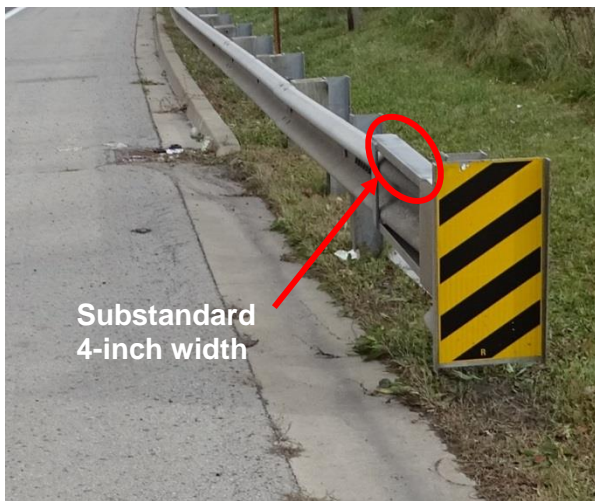
**Figure 21: Substandard 4-inch Extruder**

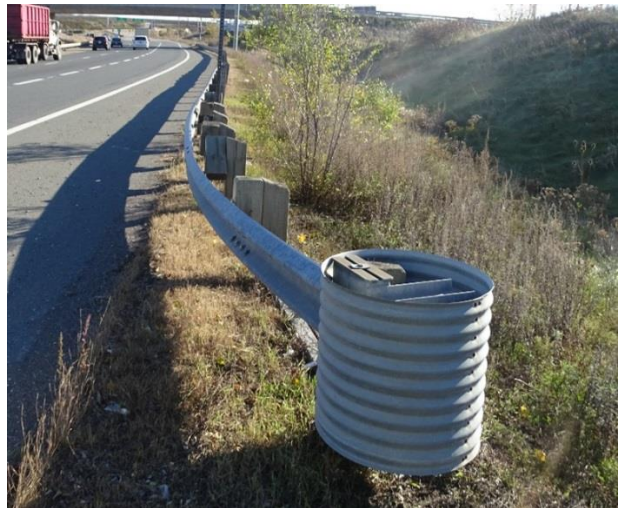
**Figure 22: Eccentric Loader**

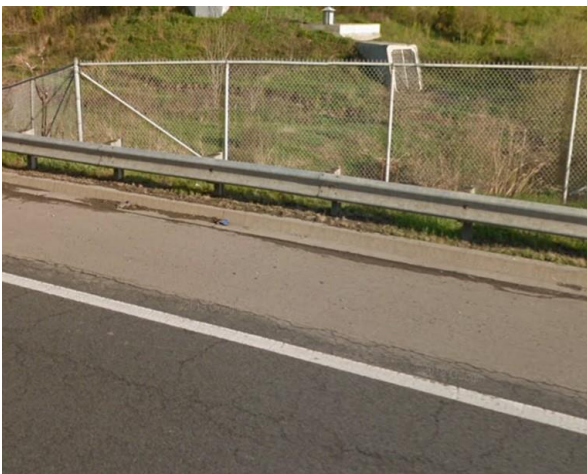
The 1993 MTO Roadside Design Guide, which was the current standard at the time of design and construction of the RHVP, states that curbs are undesirable on high speed roadways, although they may not be completely avoided. The Guide states that every effort should be made to design high speed roadways without curbs, and, if they cannot be avoided, only steel beam guide rail with channel is appropriate (when installed 250 mm behind the face of the curb). We note that it is not within the scope of this review to assess the need for curbs on the RHVP; only the appropriateness of the barrier type for the existing curb is reviewed, but it was found that some locations presented appropriate barriers (SBGR with channel) for the standards of the time, while others did not (SBGR without channel).

**Figure 23: SBGR with Barrier Curb**

term, when major reconstruction occurs, the City should consider removing curbs at high-speed locations (e.g. mainline or off-ramps).

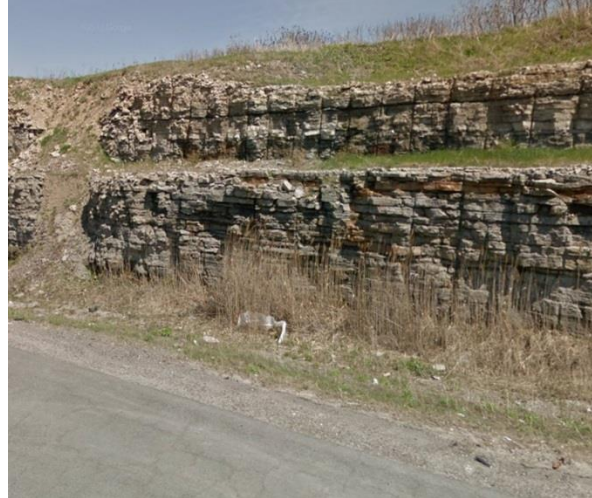
Figure 26: Rock Cut

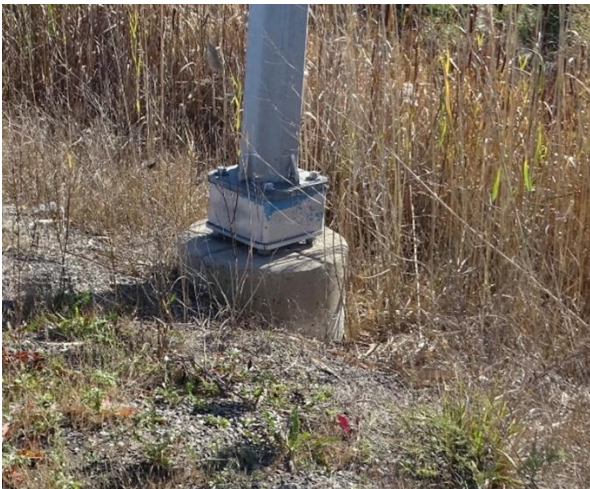
Figure 27: Fixed Objects Protruding More than 100 mm Above Ground

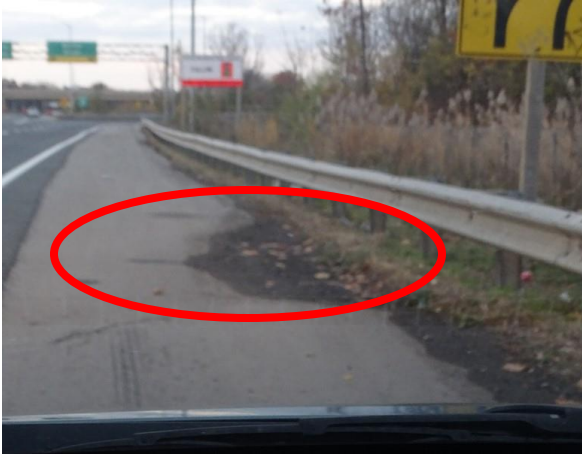
Location	Issue	Approximate Length
RHVP SB, approximately 460 m north of Barton Street (right shoulder)	Small depression on pavement	6 m
RHVP SB, approximately 540 m north of Queenston Road (right shoulder)	Pavement drop-off	10 m
RHVP SB, approximately 660 m south of Greenhill Avenue (right shoulder)	Gravel Shoulder Erosion	10 m
RHVP NB, approximately 560 m north of Mud Street (right shoulder)	Gravel Shoulder Erosion	10 m
Mud Street W-E Off Ramp, approximately 330 m east of Pritchard Road (right shoulder)	Pavement drop-off	10 m

Figure 28: Shoulder Depression

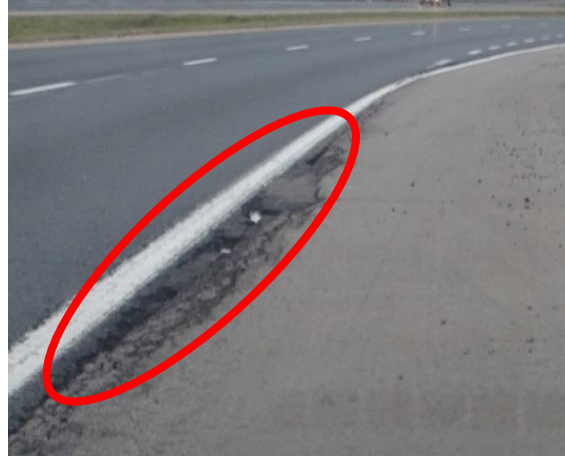
Figure 29: Pavement Edge Drop-off

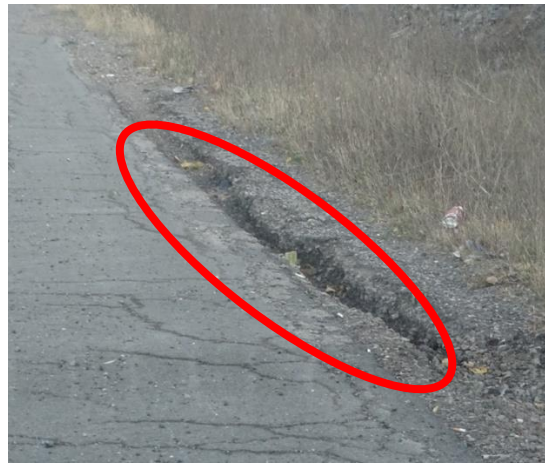
Figure 30: Shoulder Erosion

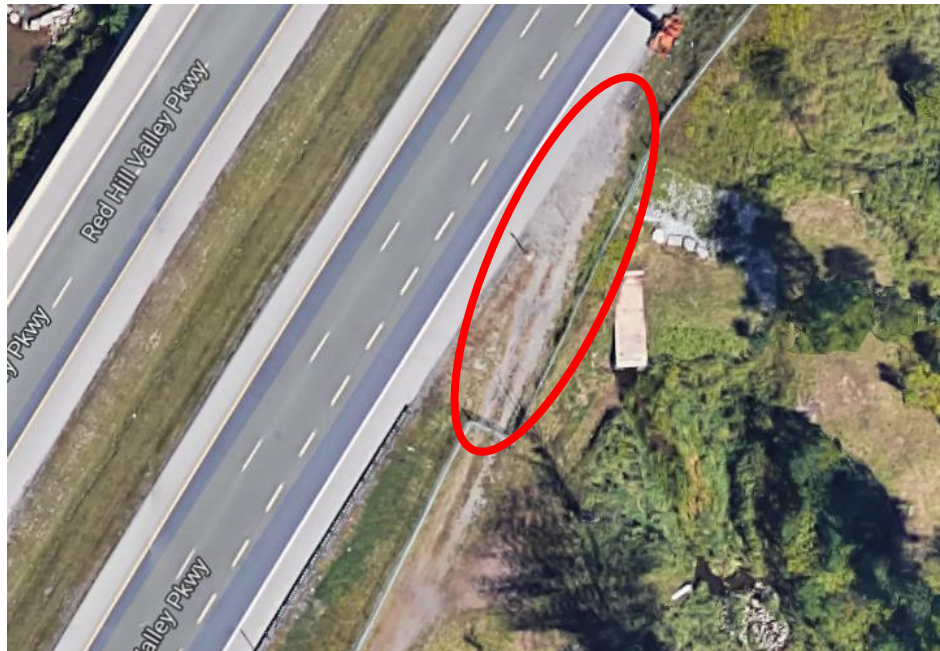
Figure 31: Unpaved Access North of Greenhill Avenue

In addition to the potential crossover locations, Hamilton Police Service requested to build up an existing unpaved service access located on the right side of the northbound lanes approximately 600 metres north of Greenhill Avenue. Hamilton Police Service reports that there's a drop-off between the shoulder and the unpaved access due to erosion. Since this is an existing access, there are no safety concerns and the access can be paved and leveled with the existing paved shoulder.

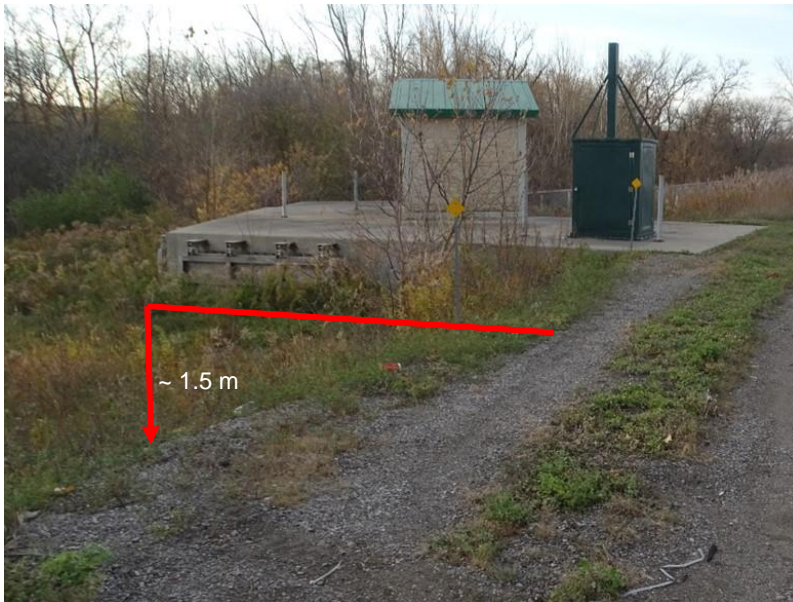
The site near Barton Street is shielded, from its south side, by a guide rail that extends continually towards the Barton Street overpass structure. Its function is to shield an embankment hazard along this section of road. Providing an opening on the south side of the facility would require the installation of an energy attenuator end treatment, which introduces a potential for frontal collisions, which are typically more severe than lateral collisions with a continuous guide rail. As such, providing an access to this facility from the south side is not recommended. The north side of the facility appears to be clear of any obstacles such as culverts and utility boxes, therefore can potentially be improved to accommodate the desired access. However, the north side of the facility presents a slope approximately 1.5-metre deep (**Figure 34**), which would require a considerable fill section.

**Figure 34: Slope Height North of HCS07C**

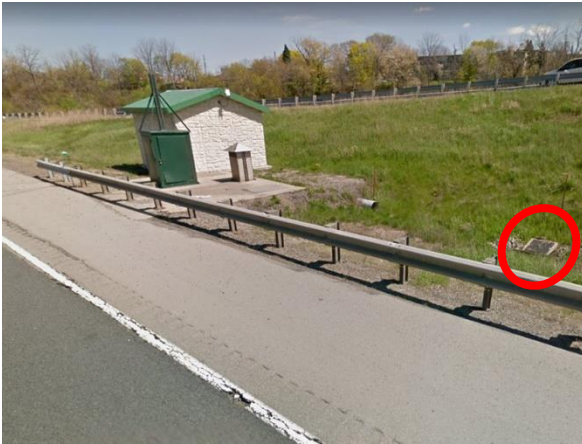
The site near Queenston Road presents a shorter guide rail on the south side, which shields the facility itself. However, a catch basin located on the south side (**Figure 35**) would prevent building up the access. On the north side, a culvert and some utility inspection boxes (**Figure 36**) are present, however the ditch is not as deep as the one at the Barton Street location (approximately 0.5 m). The culvert can potentially be extended further north to accommodate the require improvements, however the utility inspection boxes may be damaged if vehicles drive over them due to insufficient width.

**Figure 35: Catch Basin South of HCS07B**

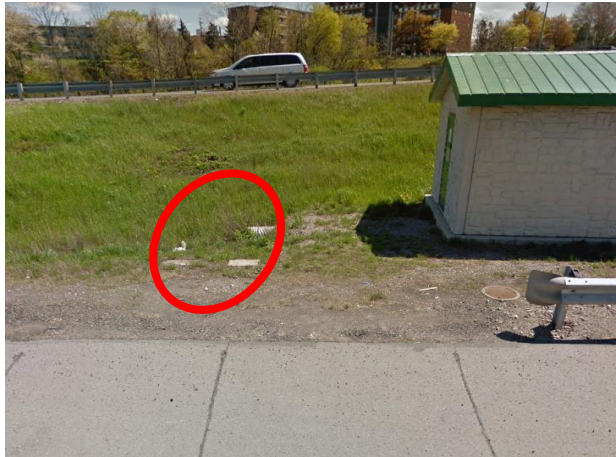
**Figure 36: Culvert/Utilities North of HCS07B**
