46-48 Ferguson Ave. S., Hamilton, ON

## Radigan Building

# CULTURAL HERITAGE IMPACT ASSESSMENT

**Issued: July 2023**

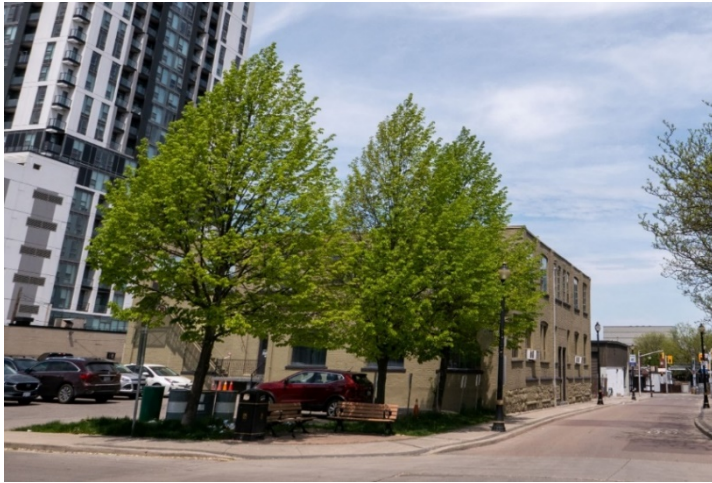
Figure 1. Looking north at the Radigan Building, set directly against Ferguson Avenue South.

setback from the sidewalk (Figure 1). A curved strip of land adjacent to property at the southeast corner is grassed, containing trees and several benches.

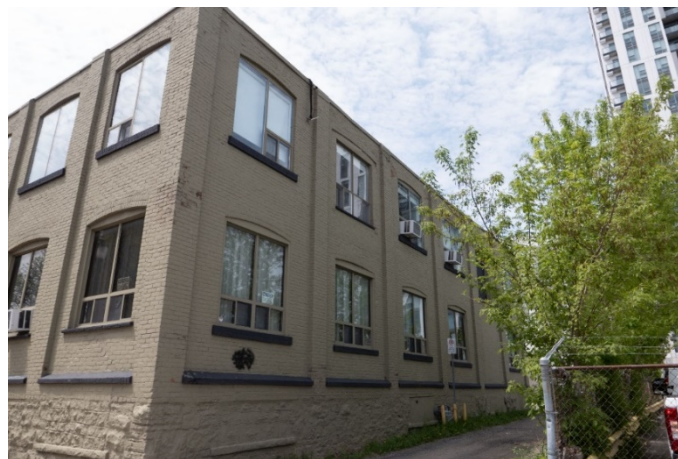
Figure 2: Looking southwest at the Radigan Building, showing the bays that characterize the design.

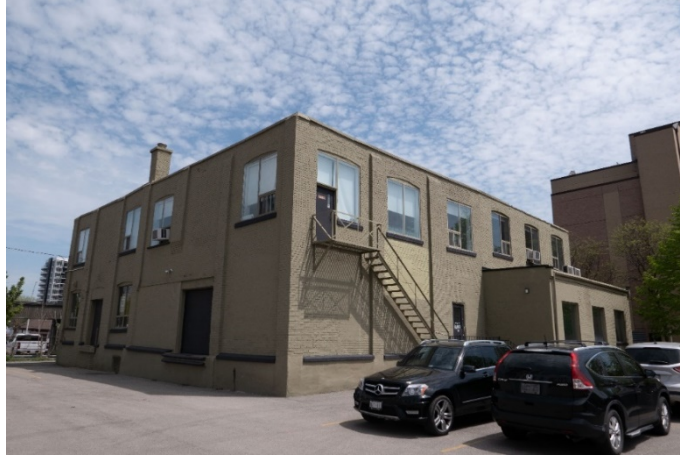
Figure 3: View to the south and west elevations of the Radigan Building.

The building has a raised foundation of coursed masonry, with brick walls rising to a flat roof. The elevations are defined by regularly spaced bays with large window openings separated by brick pilasters (Figures 2 & 3). The main elevation presents a symmetrical five-bay elevation, centred by a pair of front doors with transom windows (Figure 4). Above the doors was a sign with the building's name, date of 1905 and two floral motifs, which has since been removed (Figure 5). Aside from the symmetry and former sign, there are few aesthetic embellishments to distinguish the façade as the main elevation.

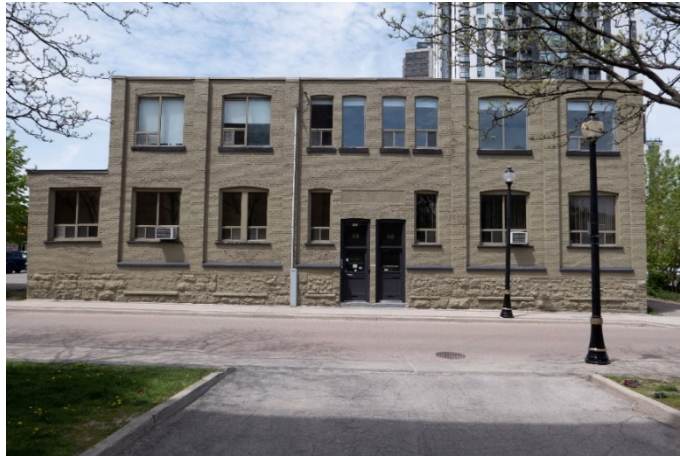
Figure 4: The Radigan Building's symmetrical main (east) elevation.

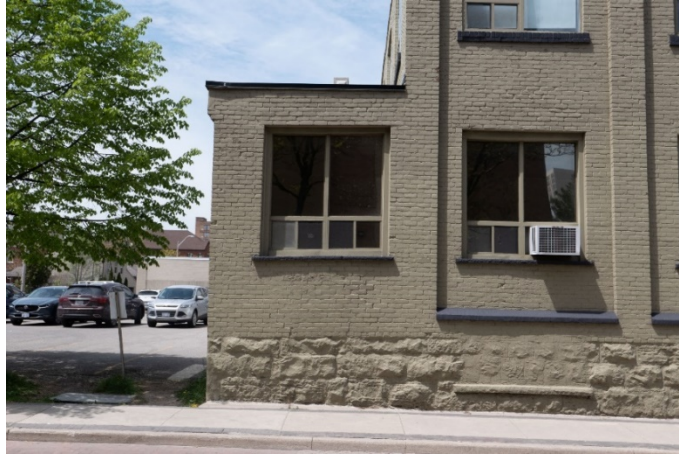
Figure 6: Non-original flat window openings seen on south end of the main elevation and south addition.

The building has been enlarged and modified numerous times. Original window and door openings feature segmental arches, while modified openings have flat lintels (Figure 6). The windows are not original, being double aluminium types with small sliding sashes. A number of window or loading door openings have been infilled on the rear and side elevations, likely to accommodate new elevator technology (Figure 7). Previous window openings to the basement in the raised foundation have since been infilled with masonry block and struck with false masonry joints. Several seams are evident in the brickwork of the north, west and south elevations, suggesting which portions of the building preceded others. A three bay one-storey addition has also been added to the south elevation.

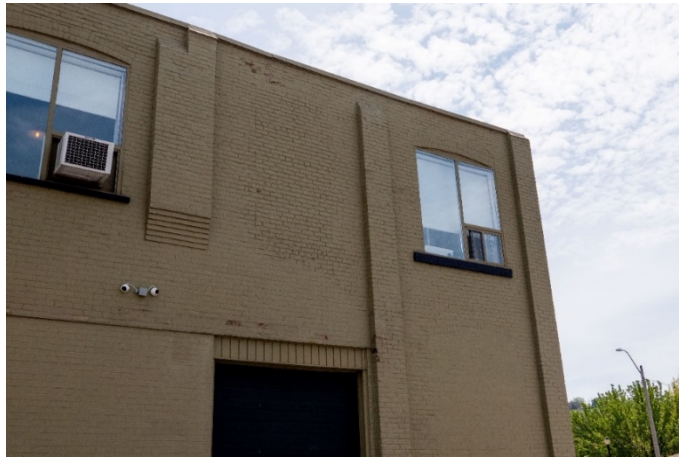
Figure 7: Infilled former window openings at the south end of the west elevation, on both stories.

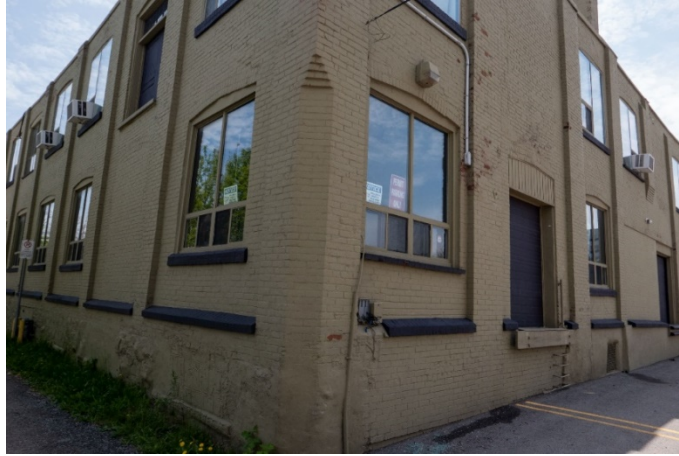
Figure 8: Decorative corbelling transitioning chamfered northwest corner.

Stretcher bond brickwork is used on the main east elevation, with common bond used on the sides and rear. Corbelling was used in several instances to reduce the profile of the building's corners (Figure 8).

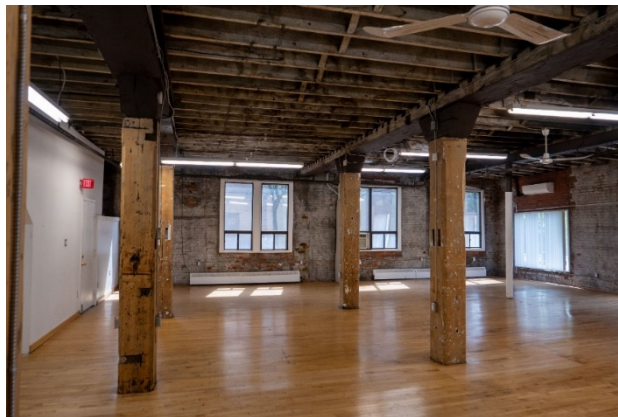
Figure 9: Ground floor of 48 Ferguson, showing salvaged timber posts and beams.

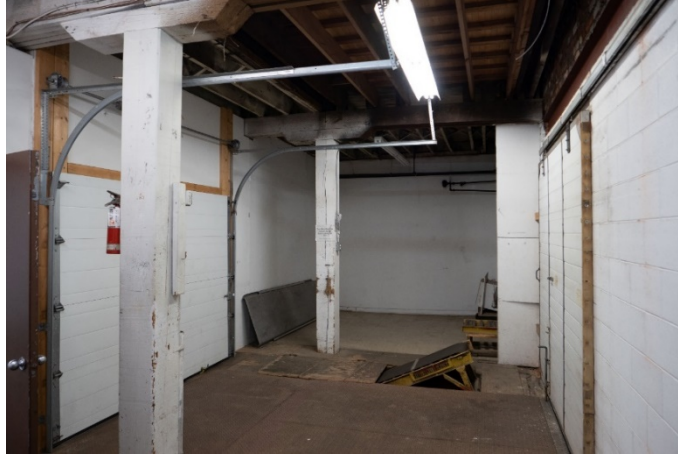
Figure 10: Smaller rooms at rear of 48 Ferguson use smaller posts and built-up beams.

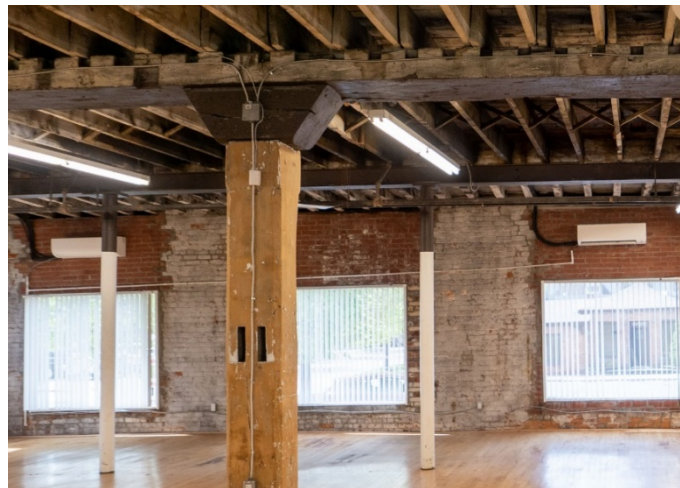
Figure 11: Detail of salvaged wood posts and beams, showing unused joist pockets and tenons.

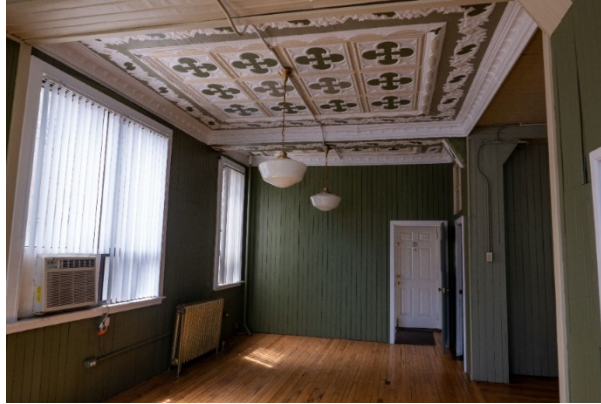
Figure 12: View of wood strip paneling on walls and tin ceilings in the office.

The 46 Ferguson side is divided between an office area and rear workshop at grade. The office is a finished space, with vertical wood panelling and several sections of elaborate, painted, pressed tin ceiling (Figures 12, 13 & 14). The area has a sage green and off-white colour scheme, pendant lamps, and a partially enclosed administrative room in the centre. The rear workshop has exposed structural finishes (Figure 15). The area contains a separate washroom, elevator and work bench area partially framed and shelved by reused wooden boxes (Figure 16). The elevator shaft is clad with rough horizontal boards, and the main machinery is exposed directly adjacent to the shaft. The shaft is accessed by wooden doors, behind which is a wooden barrier and the elevator cage (Figures 17 & 18). The elevator unit is topped by a beam advertising the Otis-Fensom Elevator Company (Figure 19).

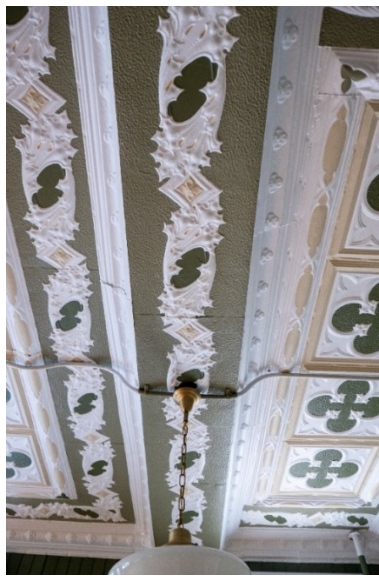
Figure 13: Detail of tin panel ceiling.

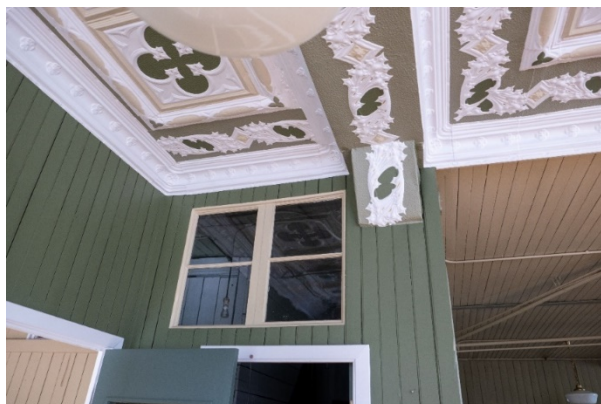
Figure 14: Office details, including transom window and tin panel ceiling.

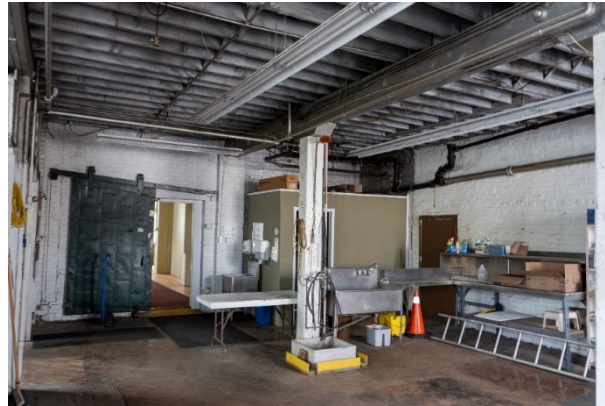
Figure 15: Rear workshop space of 46 Ferguson, with former filled in window openings visible at rear.

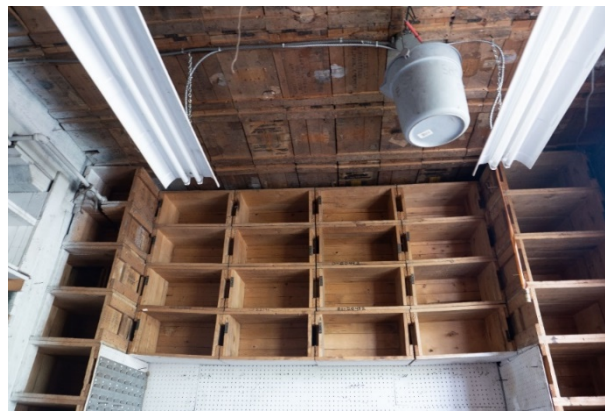
Figure 16: Re-used wooden boxes used as shelving and cladding in the rear workshop space.

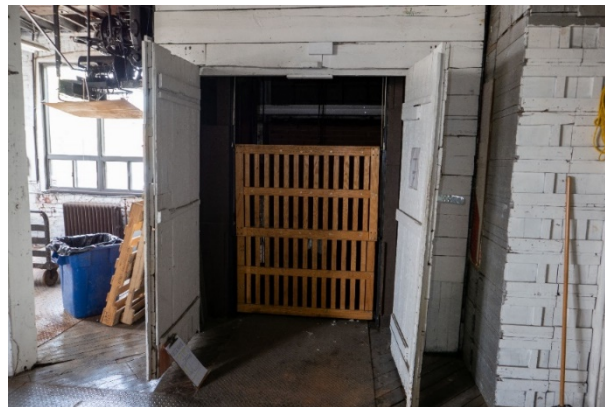
Figure 17: View of the open elevator shaft from the first floor.

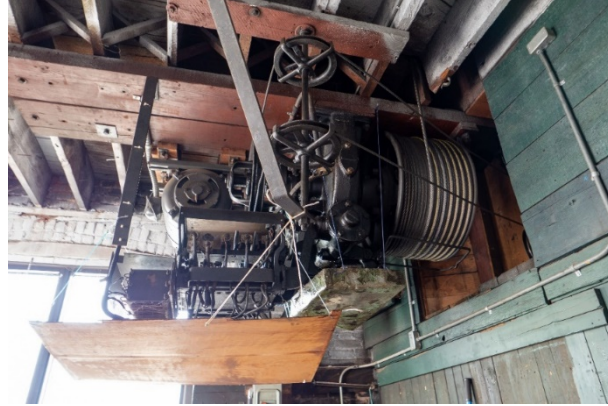
Figure 18: View of the elevator machinery on the west side of the shaft.

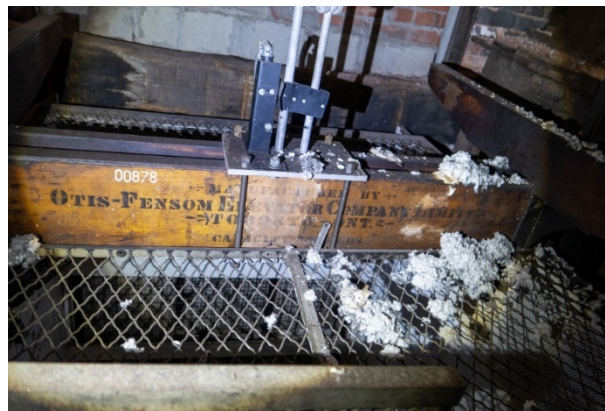
Figure 19: Otis-Fensom top beam of the elevator car.

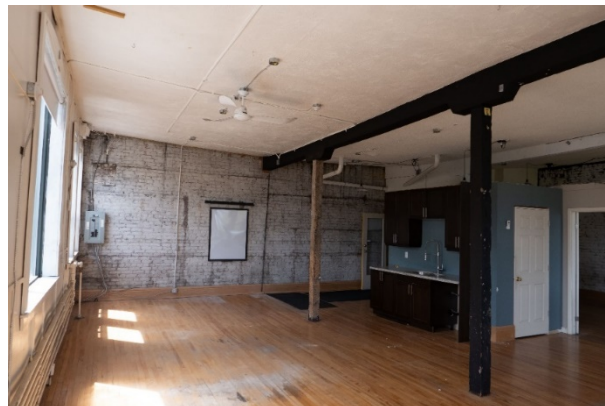
Figure 20: View of party wall and wooden posts at the second floor level.

The second storey contains four spaces to be independently occupied, accessed via central corridor with washrooms. These spaces contain full and partial partitions to suit various uses. Exposed wooden posts, beams and brick walls are found throughout the spaces (Figure 20).

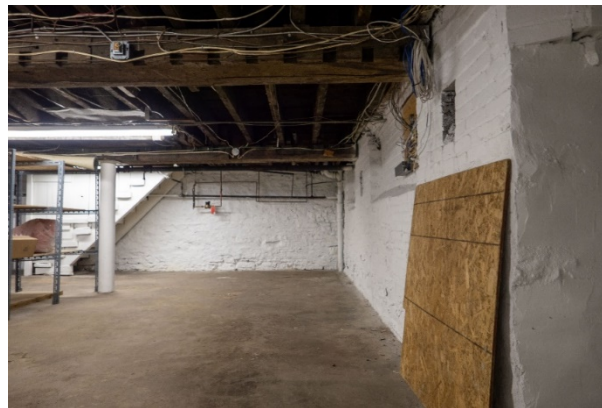
Figure 21: Looking south from the northeast quadrant of the basement at the party wall separating 46 and 48 Ferguson. The former rear foundation wall is at right, with previous window openings visible.

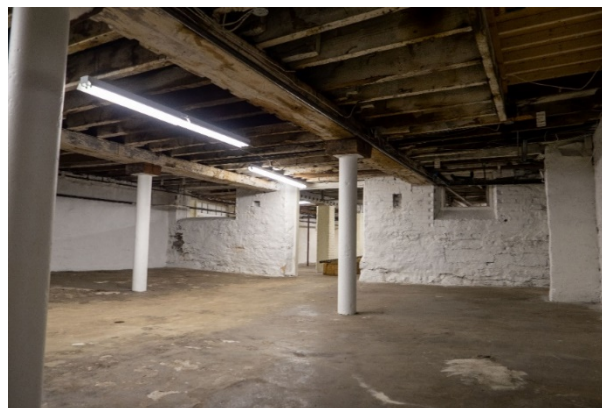
Figure 22: Looking southwest from the southeast quadrant, past the original rear foundation wall and window openings.

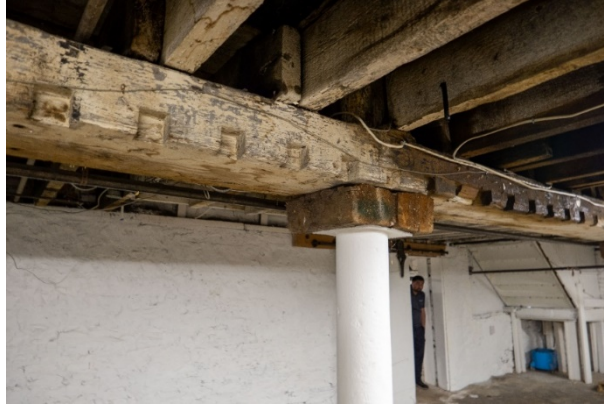
Figure 23: Salvaged wood beams and round posts under the original portion of 48 Ferguson.

The basement is a full-height space containing four equally sized open spaces. There is no basement excavated beneath the one storey addition on the south side. Masonry foundations surround the building exterior, and also bisect the east-west and north-south walls (Figures 21 & 22). The southwest quadrant contains several sections of concrete block wall, presumably applied over the existing masonry foundations. The foundation walls contain former window openings, some of which have become disused with western extensions to the building, while others have been blocked-in on the exterior. In the latter case some of the historic wood window units remain extant. The basement has concrete floors throughout, with exposed piers, beams and ceilings. The posts are metal cylinders on the eastern (original) half of the basement, and substantial brick piers on the western half, some with chamfered corners (Figures 23 & 24). The beams on the eastern half are reused wooden beams, with a similar size and joist pockets to those in the former retail space. The joists on the eastern half may have also been salvaged from the same building, matching the 3" width of the joist pockets on the beams. Three of the beams on the western half are built up from four pieces of lumber, while the southern-most one is the single salvaged type.

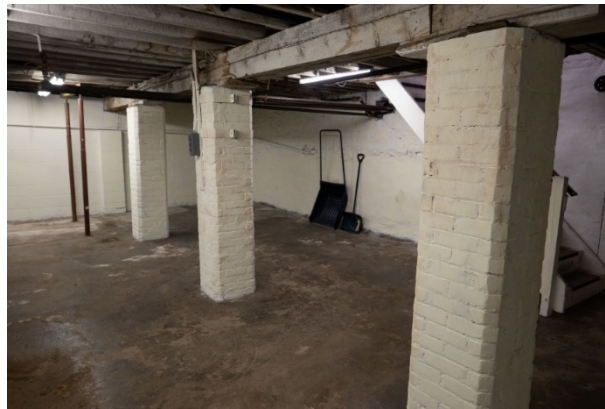
Figure 24: Brick posts supporting built-up beams in the southwest quadrant.

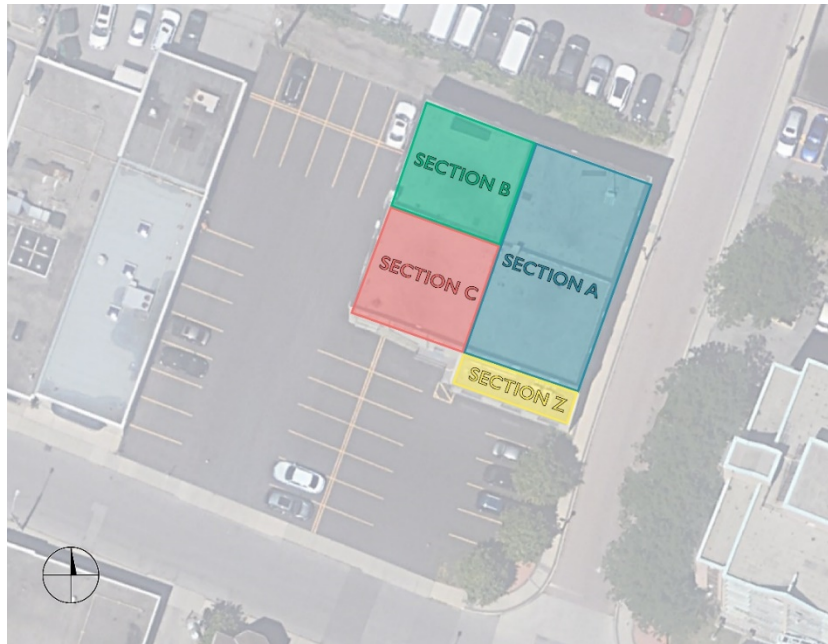
Figure 34: Diagram identifying different additions to the Radigan Building.

Site review and background research reveal that the Radigan Building was constructed as four separate segments. These are referred to as Section A; Section B; Section C and Section Z, as illustrated (Figure 34). Section A was identified as the original portion through site review, and the pair of addresses included in the 1907 city directory. The basement contains former foundations of Section A’s west wall, including window openings. Former window openings on the west wall also remain evident at the ground and second floors. Section A also contains similar construction materials, in particular massive salvaged timber beams, posts and joists. In exposed floor assemblies of Section B and C, the main beams are always built from four or more boards. The

exception is the south beam of the Section C in the basement, which matches the salvaged beams used in Section A.

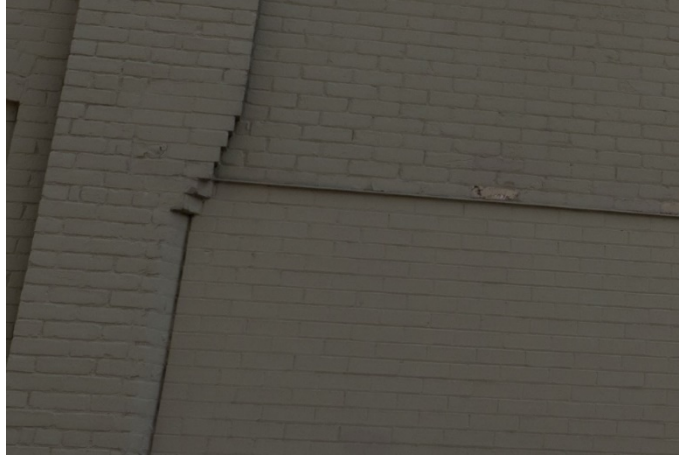
Figure 35: Brick details of Section B (left) partially obscured by the subsequent Section C addition.

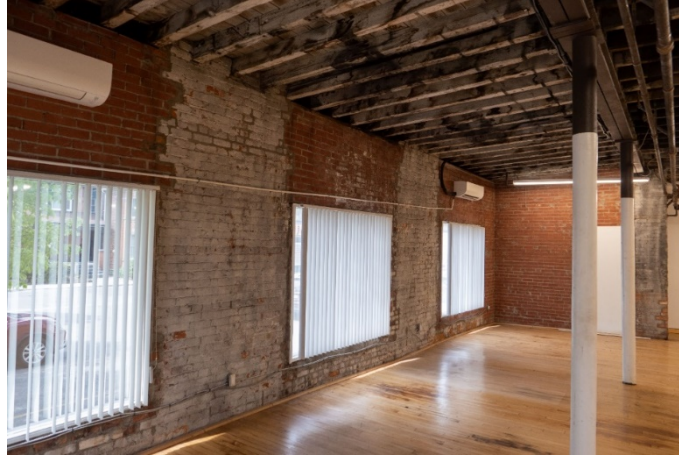
Figure 37: View of Section Z addition interior space, with steel beam and different ceiling structure.

The relative chronology of Section Z is less certain, being a smaller addition, although exposed interior brickwork suggests it was built subsequent to Section A. There is no excavated basement beneath Section Z, although it has a raised-foundation with similar masonry to Section A. A steel beam supported by posts carries the upper portion of Section A's original south wall (Figure 37).

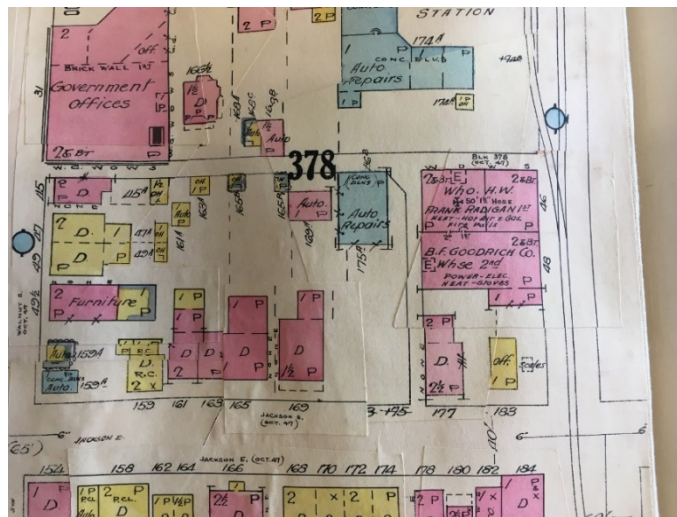
Figure 39: Detail of sheet 146 on 1947 Fire Insurance Plan (Hamilton Public Library).

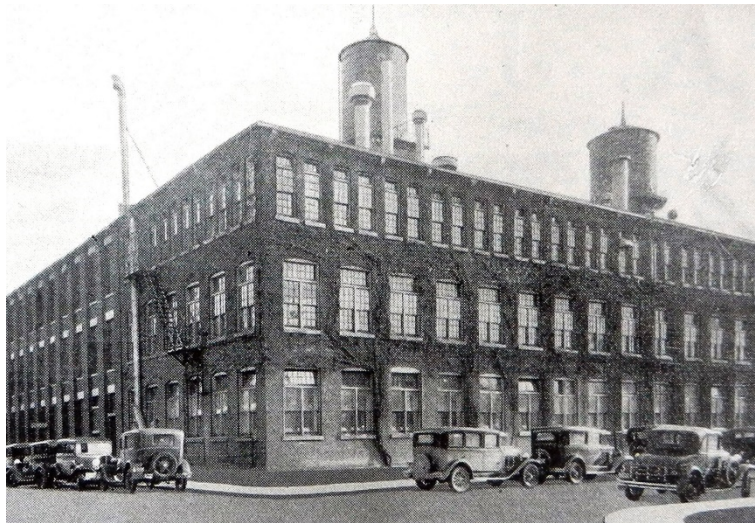
Figure 44: Photograph of the c.1911 American Can Company Factory, Hamilton, ON, showing the use of repeating bays as organizing principle (<https://mackerel-semicircle-g65b.squarespace.com/american-can-company>).

Such buildings initially featured load-bearing masonry walls, with an interior structure of wooden posts and beams providing large and flexible interior floor spaces.<sup>20</sup> This system permitted large window openings between the structural posts (often expressed as buttresses or pilasters on exterior walls) to maximize natural lighting on all elevations. The alternating pilaster - window arrangement provided the functional unit for extending the designs of buildings, ultimately ordering the elevations with the resulting number of bays (Figure 44).

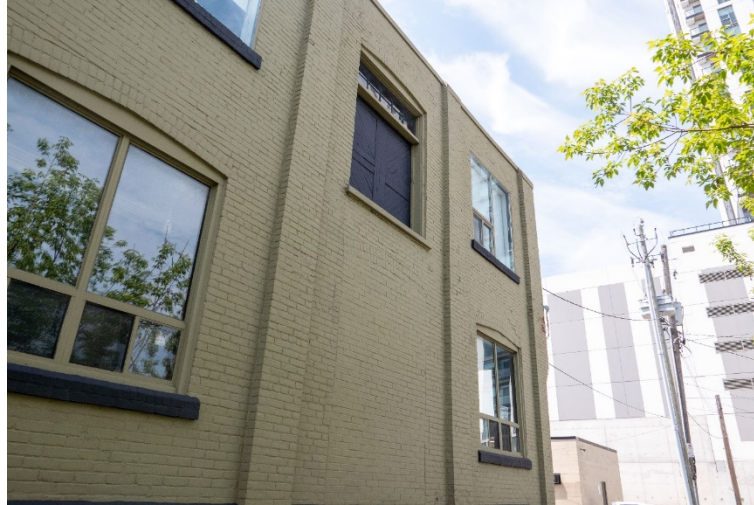
Figure 49: Former openings taller than windows at grade, and the remnant door above suggest loading functions related to the elevator .

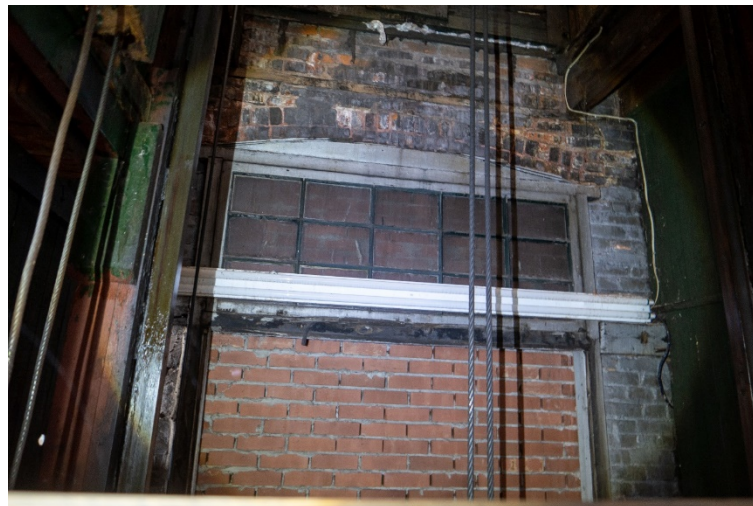
Figure 50: Former transom window remains visible inside Section B.

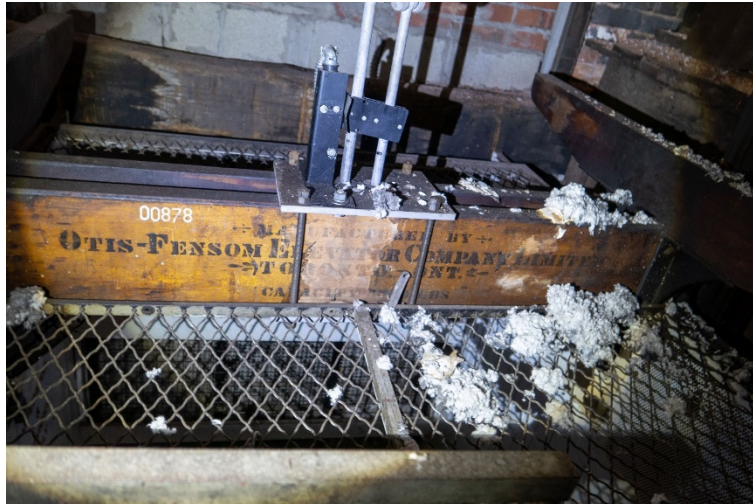
The elevator is located within a wooden framed shaft. It is an Otis-Fensom single-belt electric freight elevator. The maker is identified by the wooden top cross-beam (see Figure 51), which reads:

Manufactured By  
Otis-Fensom Elevator Company Limited  
Toronto, Ont.  
Capacity [X]000lbs

Figure 51: Former transom window remains visible inside Section B.

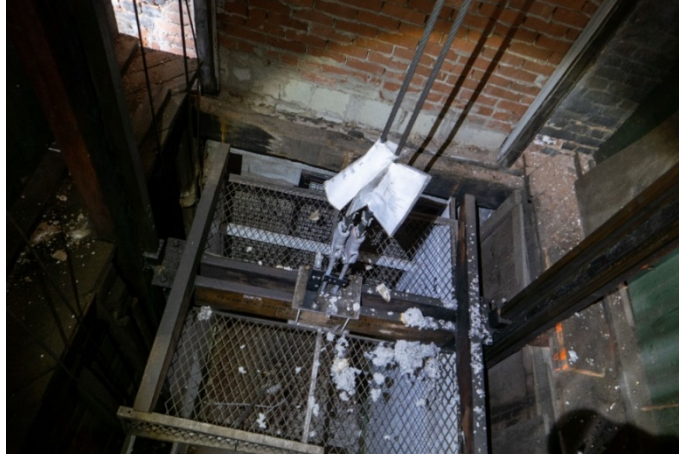
Figure 52: View of the elevator's open freight car.

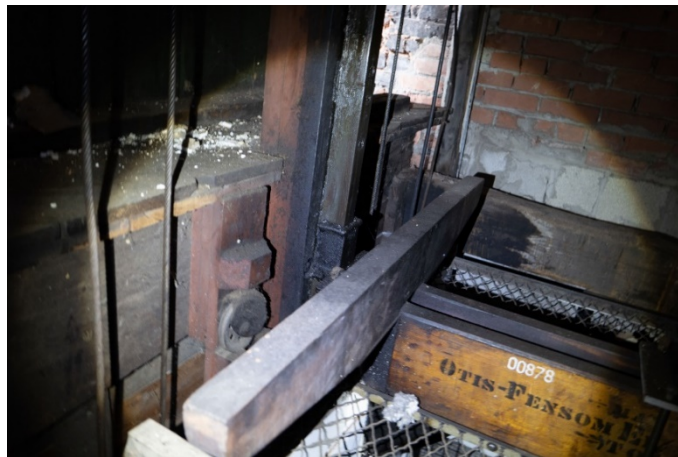
Figure 53: View of the elevator's wooden guide posts.

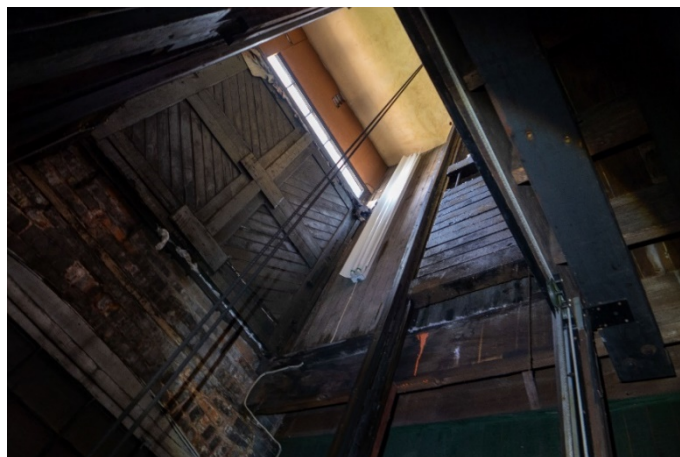
Figure 54: View of the elevator's counterweights.

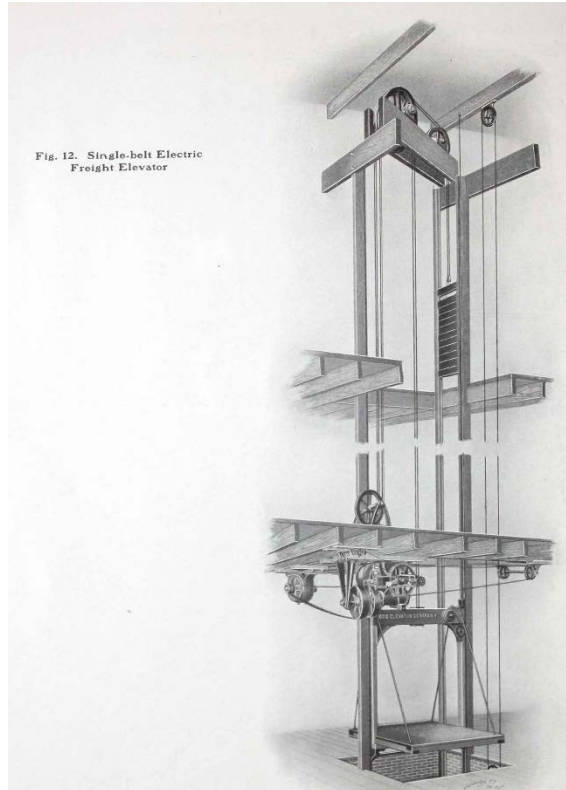
Figure 55: Rendering of a single-belt electric freight elevator system from a 1905 Otis publication ([https://archive.org/details/OtisElevatorCompanyTheOtisElevatorIndustryComprisesLarge\\_574](https://archive.org/details/OtisElevatorCompanyTheOtisElevatorIndustryComprisesLarge_574)).

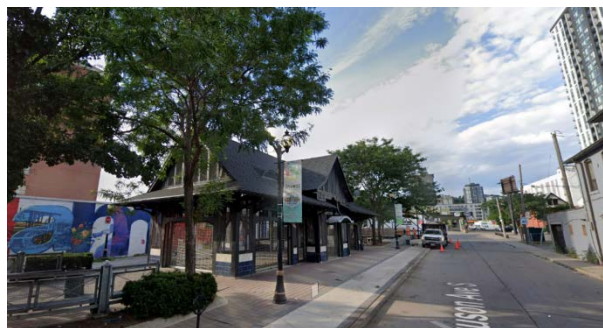
Figure 61: View of the interpretive train station gazebo building in Ferguson Station Park (Google 2022).

several former sections of track<sup>27</sup>; and Ferguson Station Park, featuring an open-air structure with a massing and roof evocative of a historic train station (Figures 59, 60 & 61).

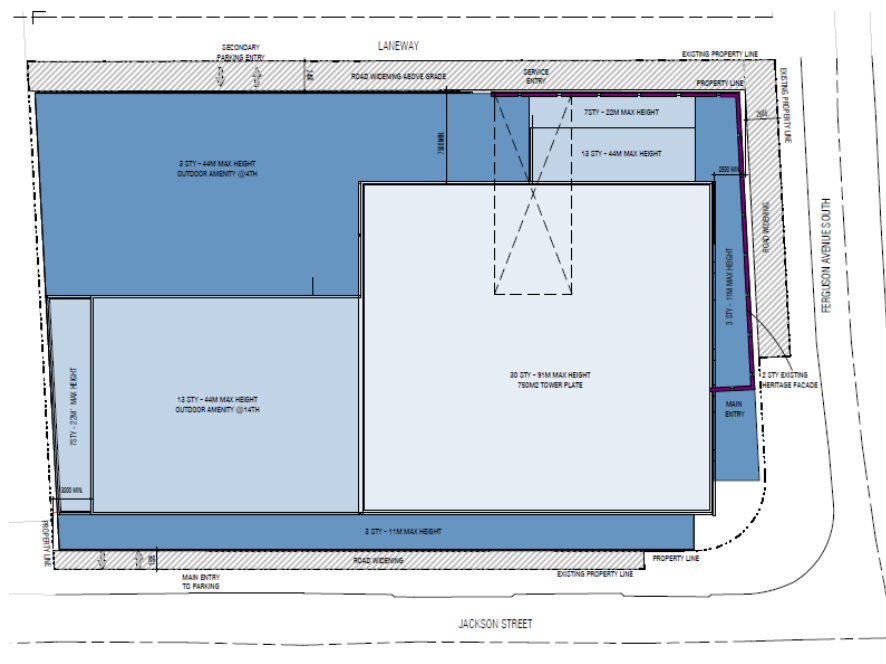
Figure 62: Conceptual Site Plan by G+C Architects indicating the heritage portion of the original building to be reconstructed.

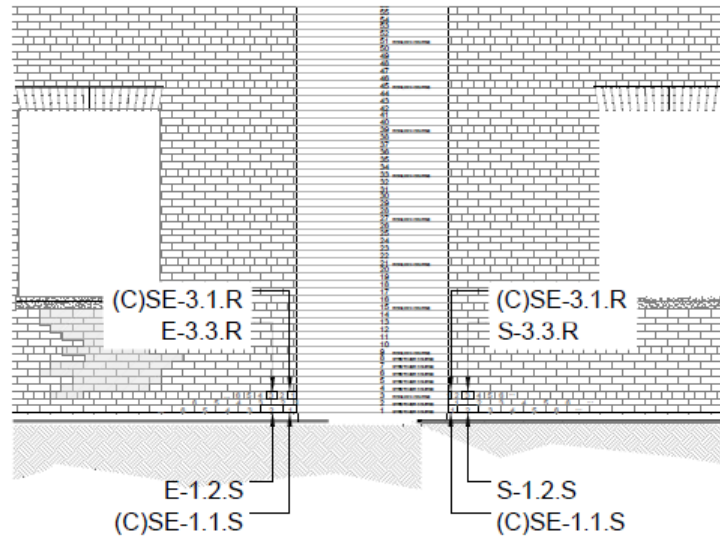
Figure 64: Reassembly Brick Coursing Guide (AREA, October 2018)

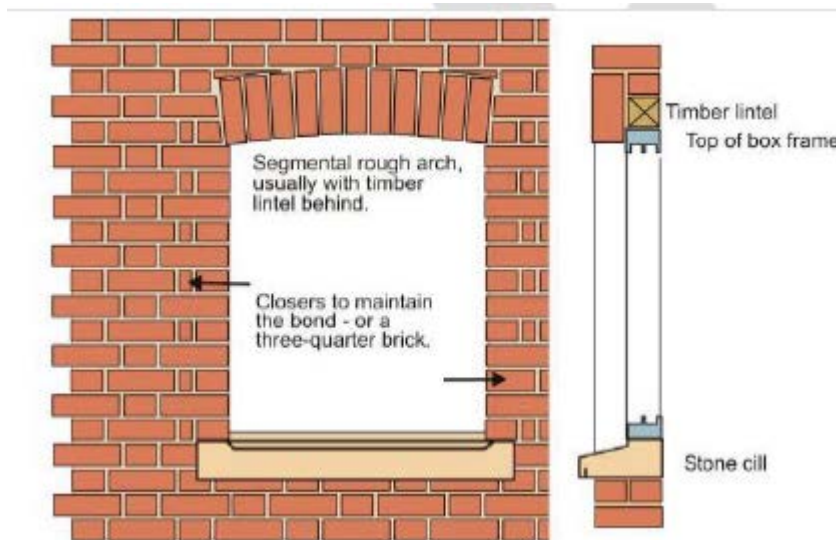
Figure 65: Segmental Gauge Arch, Construction Detail

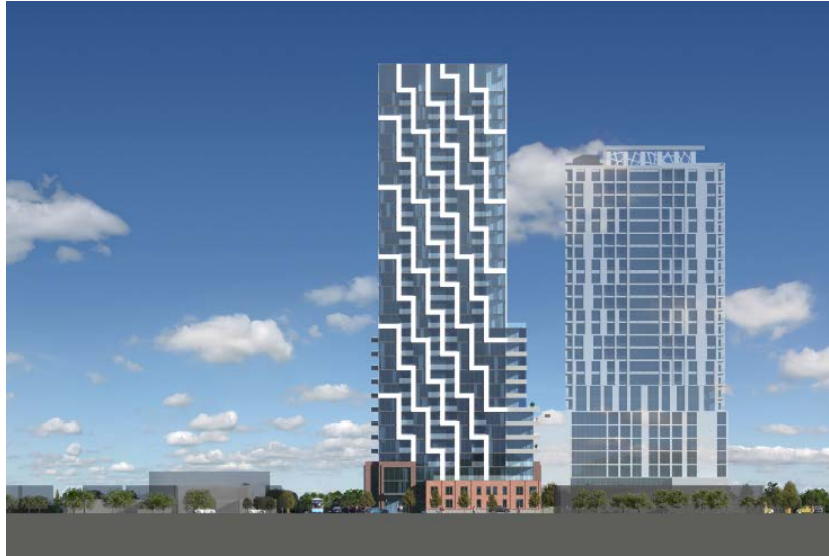
Figure 66: East Elevation of the proposed development showing the reconstructed façade of Radigan Building, G+C Architects, June 2023.

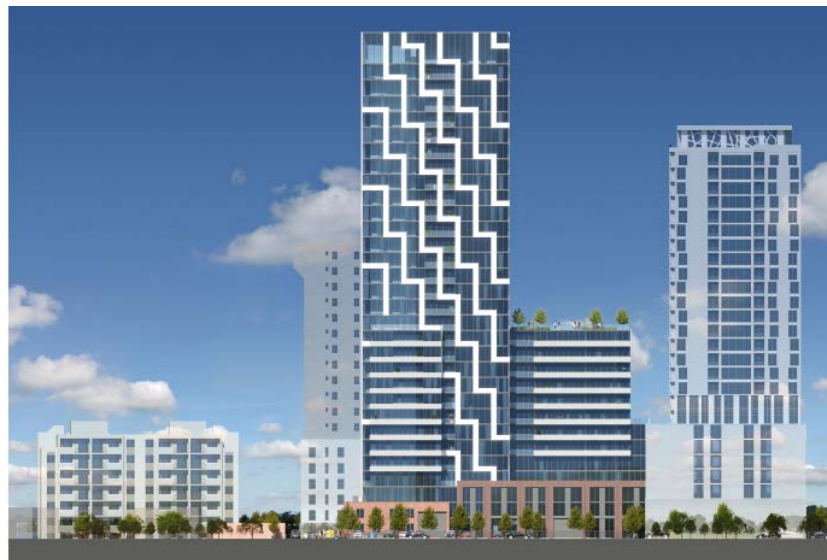
Figure 67: North Façade of the Radigan Building, integrated into the proposed multi-residential condominium development, G+C Architects, June 2023.

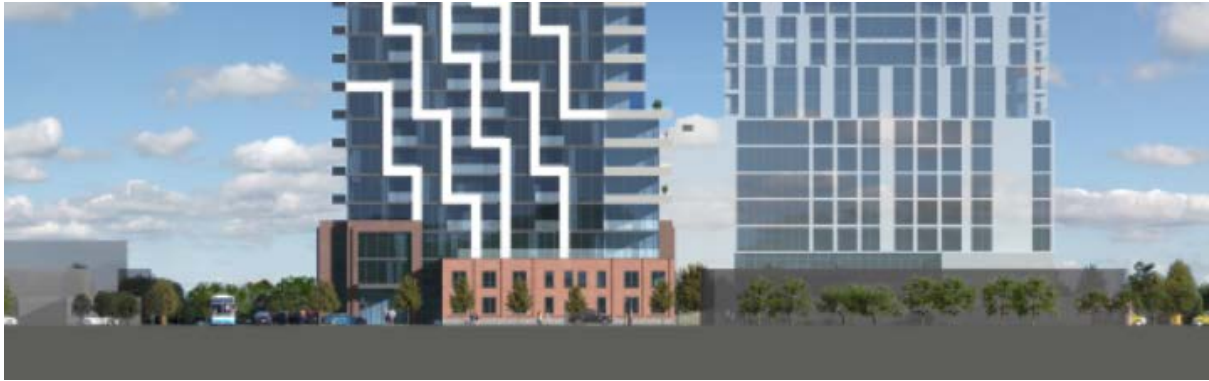
Figure 68: East Elevation enlarged detail of the proposed development showing the reconstructed façade of Radigan Building, G+C Architects, June 2023.

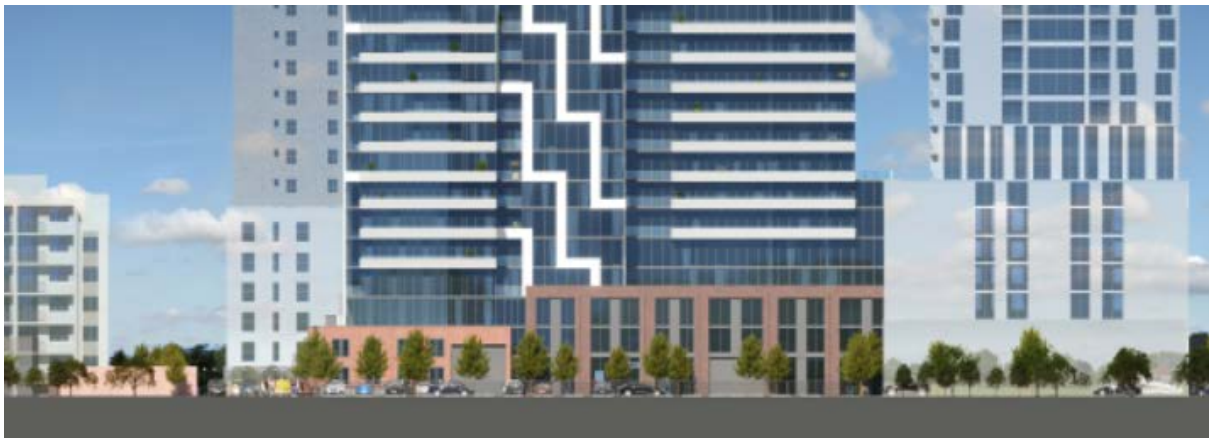
Figure 69: North Elevation enlarged detail of the proposed development showing the reconstructed façade of Radigan Building, G+C Architects, June 2023.

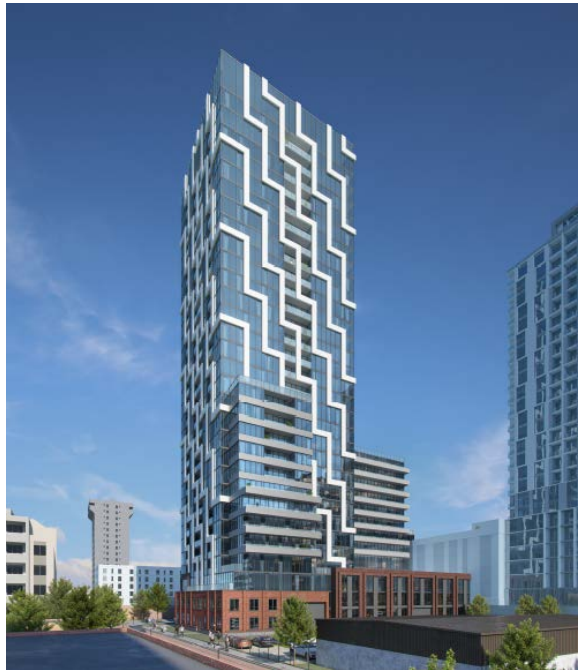
Figure 70: Perspective southwest view, conceptual, of the reconstructed heritage facades in the proposed new development (G+C Architects, June 2023)

The Ferguson Avenue South streetscape will physically be altered and improved by the proposed landscape upgrades and the shift of the building façade further away from the street edge. The modifications and development will provide the site with a modern aesthetic while integrating seamlessly through material compatibility with the existing heritage value of the area. By incorporating the heritage building into the development, it will reinforce the character of Corktown Established Historical Neighbourhood (CEHN) by acting as an anchor. The development is expected to have a positive impact on the Ferguson Avenue South streetscape by providing a pedestrian friendly space around the site and the existing heritage buildings while also highlighting the historic attributes of the street.
