TO:	Mayor and Members Board of Health
DATE:	September 15, 2023
SUBJECT:	Air Monitoring On-Site Assessment at Green for Life Stoney Creek Regional Facility (City Wide)
WARD(S) AFFECTED:	Ward 9
SUBMITTED BY:	Dr. Elizabeth Richardson, MD, MHSc, FRCPC Medical Officer of Health Public Health Services
SIGNATURE:

September 1, 2023

RE: **GFL Environmental August 2023 Air Monitoring On-Site
Assessment Survey, Stoney Creek, Ontario**

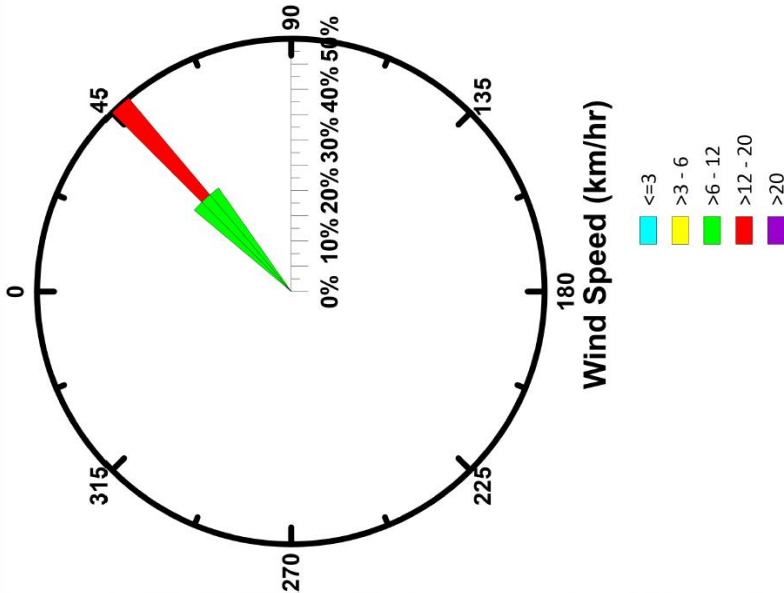
Figure 10 - GFL Environmental August 2023
Air Monitoring On-Site Assessment Survey - Aug 28, 2023

Detectable concentrations of toluene, 1,3-dimethylbenzene and hydrogen sulphide were measured from approximately 12:30 to 13:15 at Location 1 (dog park). Table 2 below summarizes the measured concentrations and compares against Emergency Screening Values (ESV) used during emergency response, worker safety standards and Ontario Ambient Air Quality Criteria (AAQC). Measured concentrations of toluene and 1,3-dimethylbenzene were well below all the standards they were compared against.

A hydrogen sulphide (H_2S) concentration of 0.0084ppm or $11.61 \mu g/m^3$ was measured. This was well below the worker safety standards and was close to (but still below) the 10-min (odour-based) AAQC of $13 \mu g/m^3$. Total reduced sulphur (TRS) measured a maximum 10-min average of 5ppb, or $12 \mu g/m^3$ (assuming an equal mixture of the sulphur compounds listed under the AAQC) which was below the 10-min (odour-based) AAQC of $13 \mu g/m^3$. The concentrations of both hydrogen sulphide and TRS were below their respective odour-based AAQCs. Since they are measured continuously, both H_2S and TRS can be compared directly to the 10-min criteria.

Date	Time (Location)	Name	HAPSITE Comments:	Other compounds (PM, H ₂ S, Nox, CO or SO ₂)	Odours observations	General Comments
28-Aug-23	12:33	1	Toluene: 8.7 ug/m3 1-3-dimethylbenzene: 3.6 ug/m3	Slightly elevated H2S	Yes	Odour Survey Conducted. Odours detected
	12:55		No Compounds Detected	Measured H2S concentrations as high as 8.4 ppb	Yes	
	13:12		No Compounds Detected		No	
	13:28	2	No Compounds Detected		Yes	
	13:47	3	No Compounds Detected		No	
	14:05	4	No Compounds Detected		Yes	
14:22	5	No Compounds Detected		No		
14:47	6	No Compounds Detected		No		
15:03					Yes

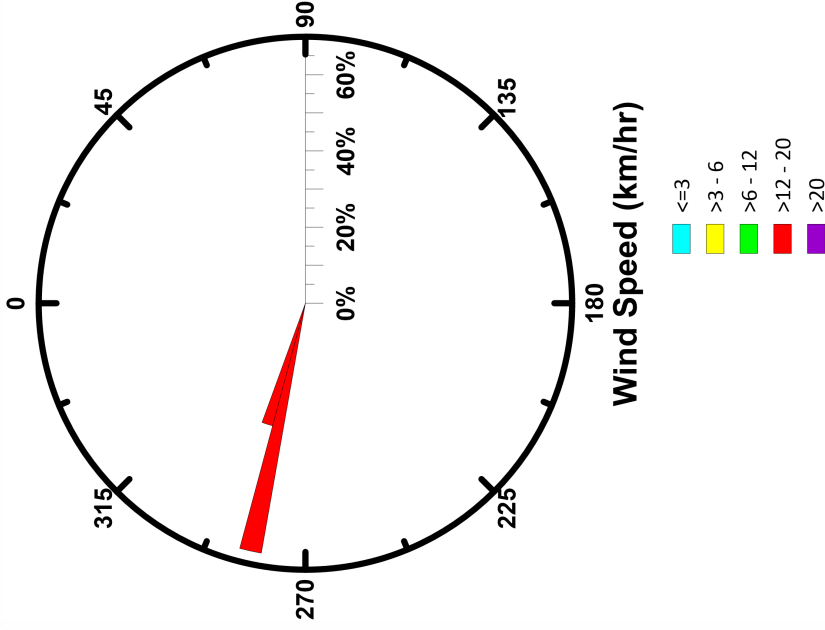
Figure 2 - GFL Environmental August 2023 Air Monitoring On-Site Assessment Survey - Aug 8, 2023

HAPSITE compounds and other compounds were not detected on this sampling day. The technician detected a slight odour at 15:30 but could not be quantified using the nasal ranger (D/T<2). Winds were also blowing from the west where the leachate pond was upwind and a probable source. The technician did not detect odours from other sampling locations including those downwind of the GFL Facility.

Date	Time (Location)	Name	HAPSITE Comments:	Other compounds (PM, H ₂ S, Nox, CO or SO ₂)	Odours observations	General Comments
08-Aug-23	15:15	A	No Compounds Detected		There was a slight odour coming from the leachate ponds at 15:30	
	15:30					
	15:48					
	16:05	B				
	16:21					
	16:38	C				
	16:54					
	17:15					
	17:30	E

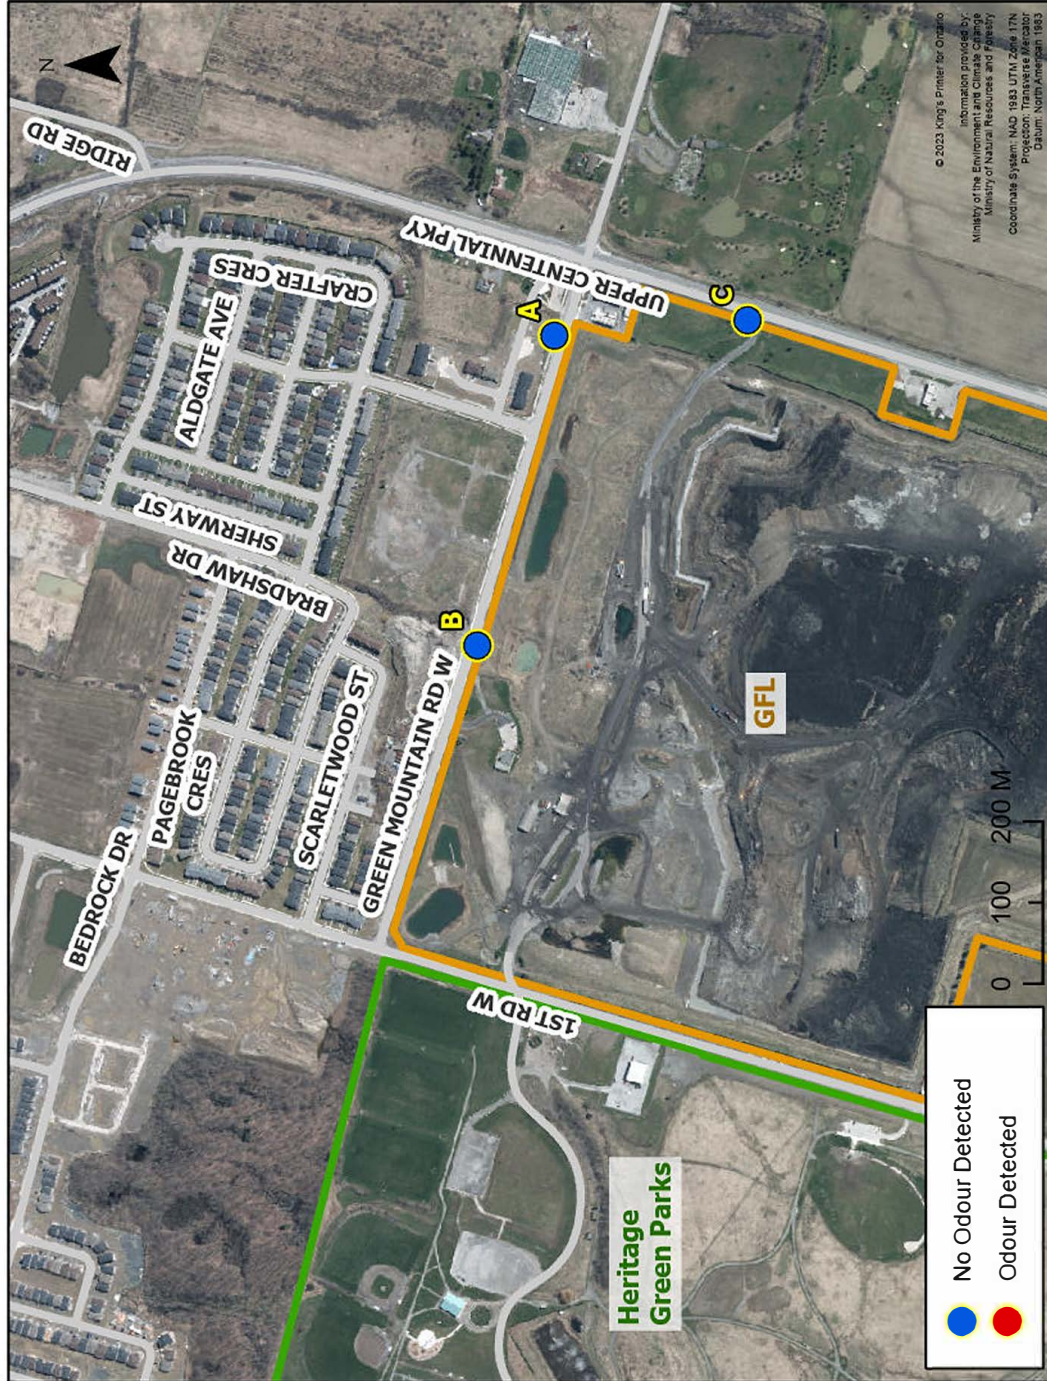
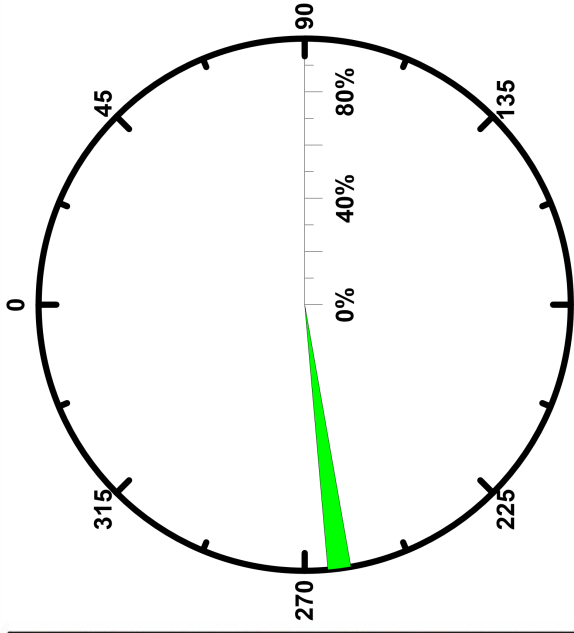
Figure 3 - GFL Environmental August 2023 Air Monitoring On-Site Assessment Survey - Aug 9, 2023

HAPSITE compounds and other compounds were not detected on this sampling day. No odours were detected by the technician. Winds were blowing from the west where the GFL Facility was upwind of one sampling location.

Date	Time (Location)	Name	HAPSITE Comments:	Other compounds (PM, H ₂ S, Nox, CO or SO ₂)	Odours observations	General Comments
09-Aug-23	9:00	A	No compounds detected	-	No offensive odours	-
	9:20					
	9:30	B				
	9:45					
	10:00	C

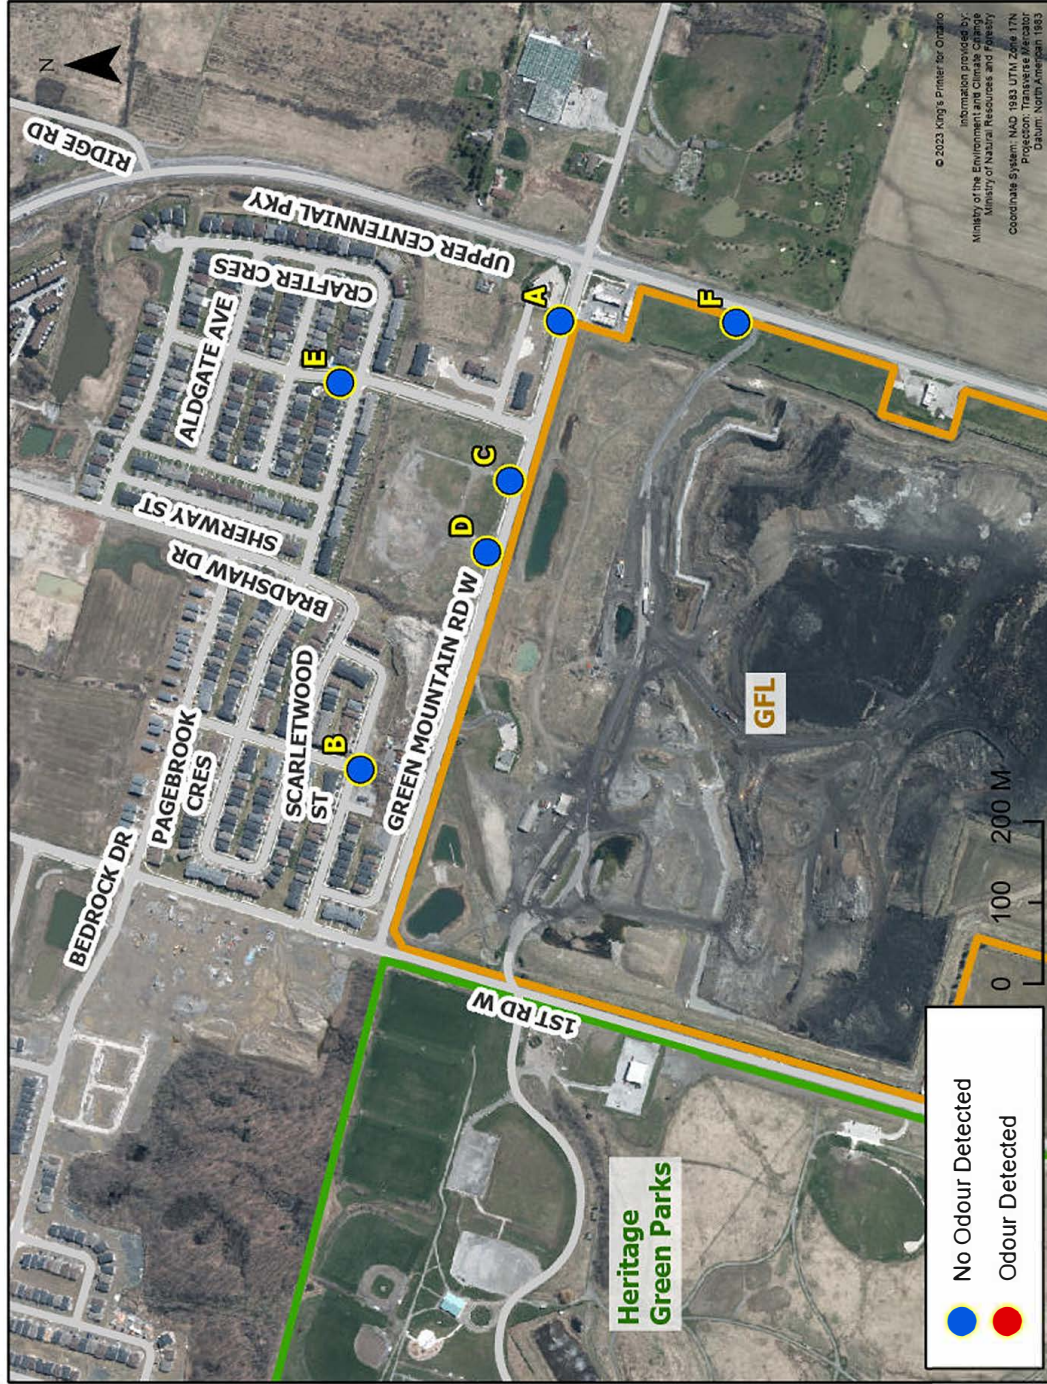
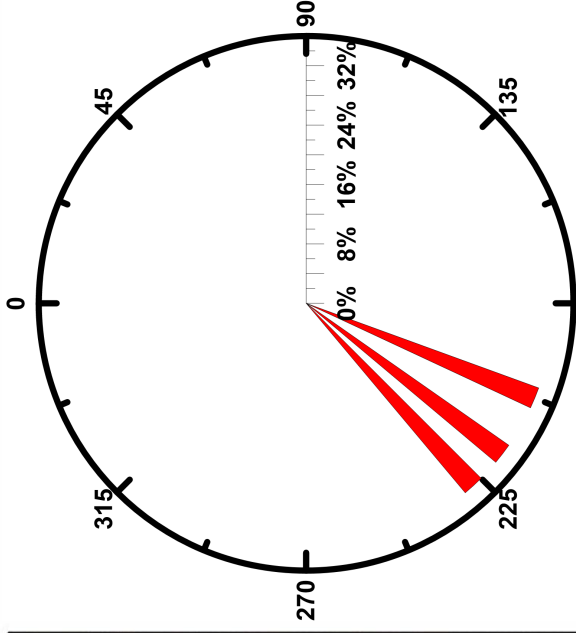
Figure 4 - GFL Environmental August 2023 Air Monitoring On-Site Assessment Survey - Aug 10, 2023

HAPSITE compounds and other compounds were not detected on this sampling day. No odours were detected by the technician. Winds were blowing from the south to southwest where the Facility was upwind of most sampling locations.

Date	Time (Location)	Name	HAPSITE Comments:	Other compounds (PM, H ₂ S, Nox, CO or SO ₂)	Odours observations	General Comments
10-Aug-23	8:45	A	No compounds detected	-	No offensive odours	-
	9:00	B				
	9:20	C				
	9:40	D				
	10:00	E				
	10:15	F

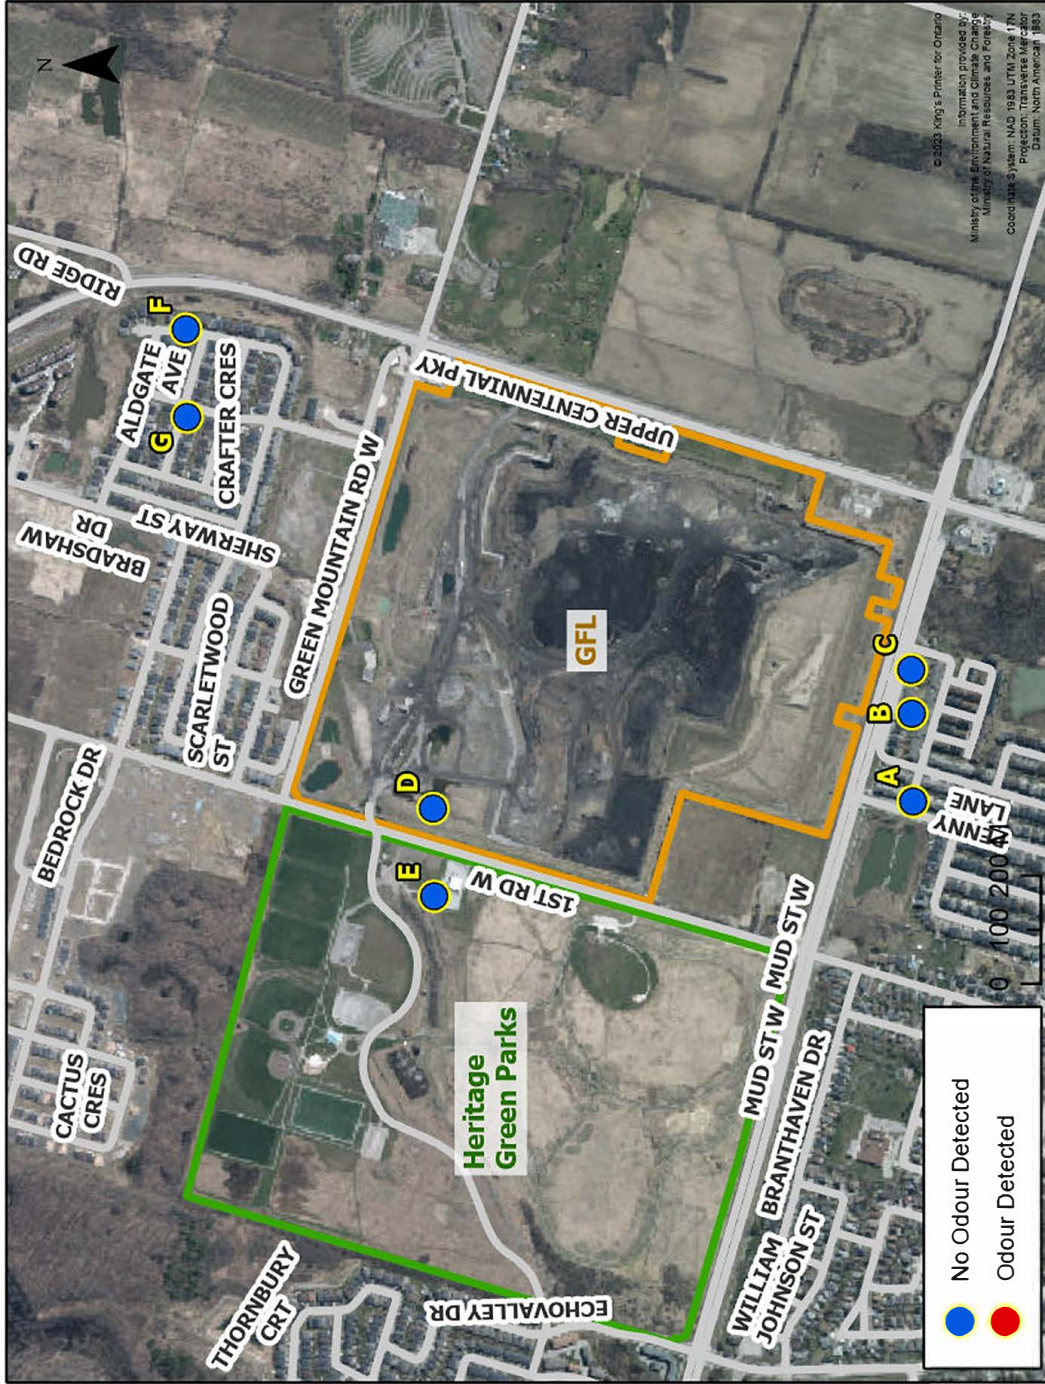
Figure 5 - GFL Environmental August 2023 Air Monitoring On-Site Assessment Survey - Aug 16, 2023

HAPSITE compounds and other compounds were not detected on this sampling day. No odours were detected by the technician. Winds were generally blowing from the southwest where the Facility was upwind of a few sampling locations.

Date	Time (Location)	Name	HAPSITE Comments:	Other compounds (PM, H ₂ S, Nox, CO or SO ₂)	Odours observations	General Comments
16-Aug-23	13:42	A	No compounds detected			
	13:58	B				
	14:21	C				
	14:38	D				
	14:54	E				
	15:12	F				
	15:30	G				
16:02						
16:49

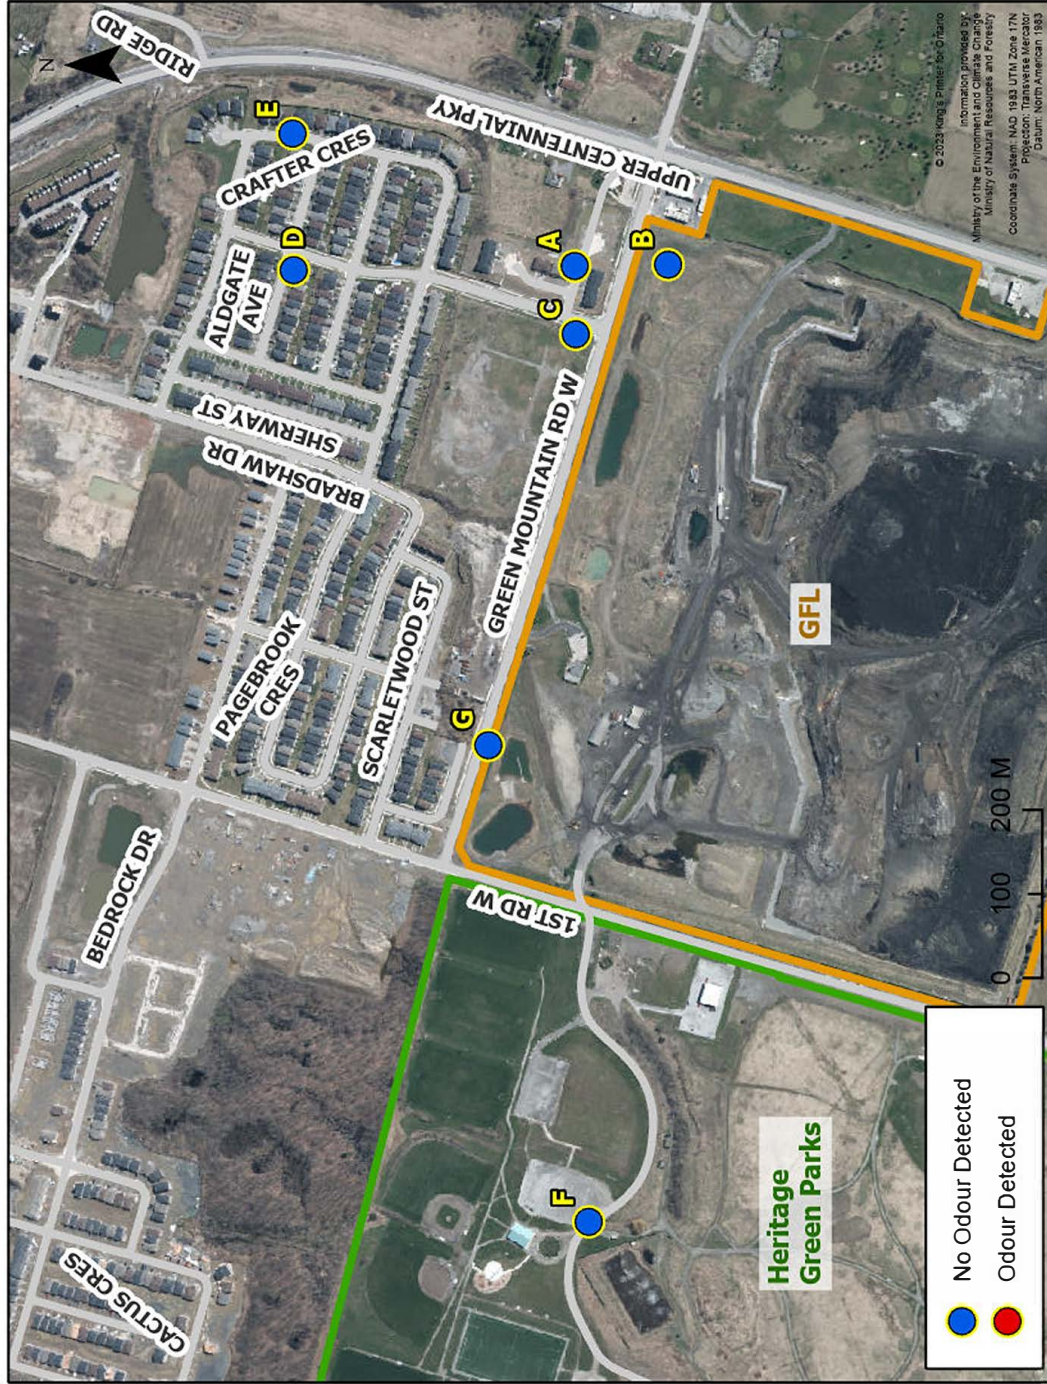
Figure 6 - GFL Environmental August 2023 Air Monitoring On-Site Assessment Survey - Aug 17, 2023

HAPSITE compounds and other compounds were not detected on this sampling day. No odours were detected by the technician. Winds were generally blowing from the south-southwest where the Facility and leachate pond was upwind of most sampling locations.

Date	Time (Location)	Name	HAPSITE Comments:	Other compounds (PM, H ₂ S, Nox, CO or SO ₂)	Odours observations	General Comments
17-Aug-23	14:00	A	No compounds detected			
	14:20	B				
	14:40	C				
	14:58	D				
	15:15	E				
	15:30	F				
	16:05	G

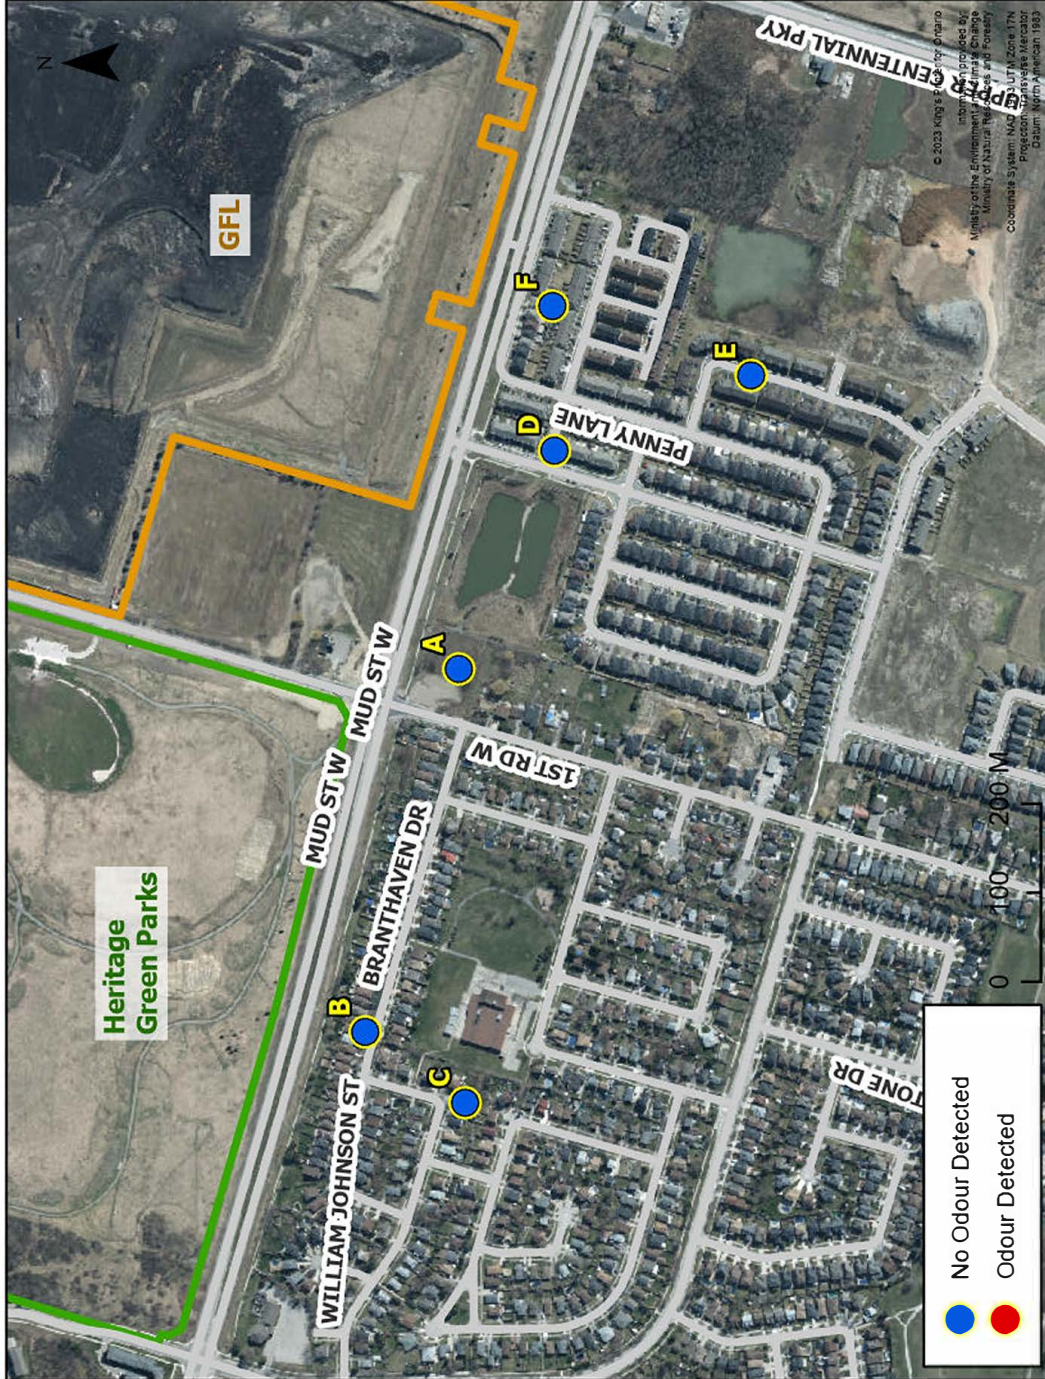
Figure 7 - GFL Environmental August 2023 Air Monitoring On-Site Assessment Survey - Aug 21, 2023

HAPSITE compounds and other compounds were not detected on this sampling day. No odours were detected by the technician. Winds were generally blowing from the northeast where the Facility was upwind.

Date	Time (Location)	Name	HAPSITE Comments:	Other compounds (PM, H ₂ S, Nox, CO or SO ₂)	Odours observations	General Comments	
21-Aug-23	12:30	A	No compounds detected	-	-	-	
	12:50						
	13:08						
	13:24	B					
	13:45						C
	14:00						
14:18	D						
14:35		E					
14:55	F

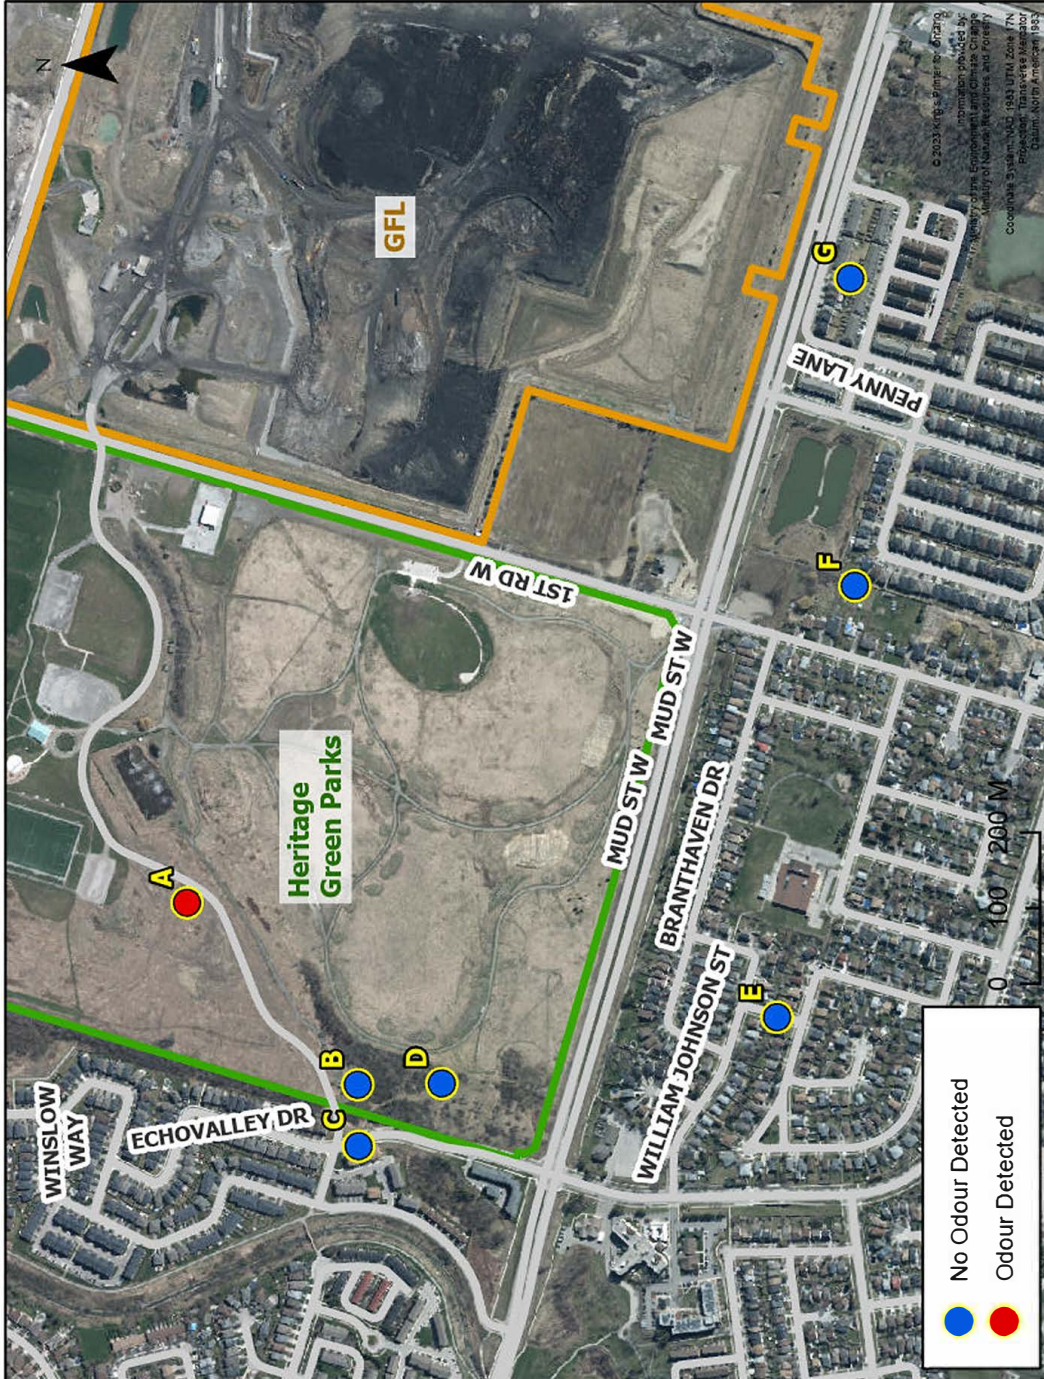
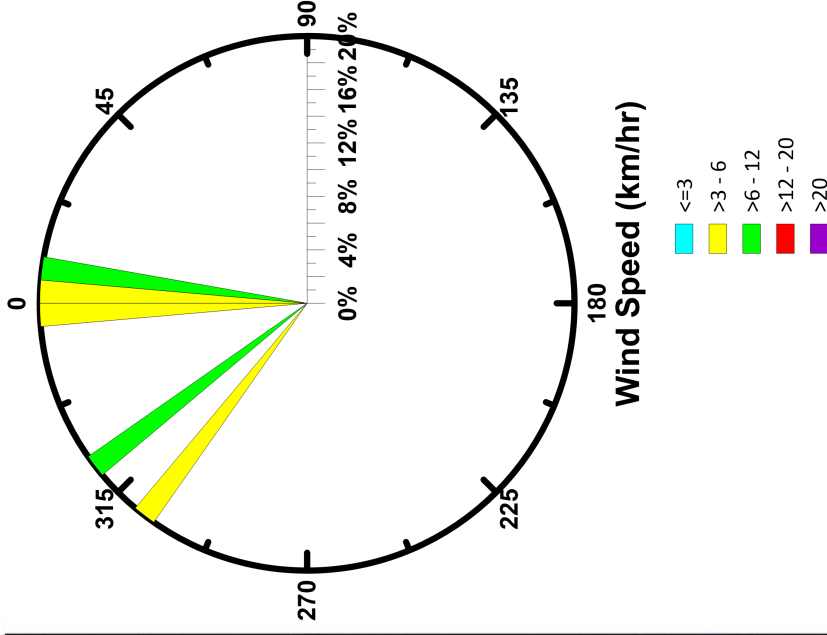
Figure 8 - GFL Environmental August 2023 Air Monitoring On-Site Assessment Survey - Aug 24, 2023

HAPSITE compounds and other compounds were not detected on this sampling day. The technician detected a wet diaper/ urine/ portable toilet odour at a sampling location somewhat downwind of the leachate pond which may have been an odour source. The odour could not be quantified using the nasal ranger (D/T<2). Winds were generally blowing from the northwest to north where the sampling points were downwind of residential, the leachate pond and the GFL Facility.

Date	Time (Location)	Name	HAPSITE Comments:	Other compounds (PM, H ₂ S, NOx, CO or SO ₂)	Odours observations	General Comments
24-Aug-23	11:30	A	No Compounds Detected	-	Yes	Wet diaper, urine/ porta potty odour
	11:45	A				
	12:05	A				
	12:18	A	No Compounds Detected	-	No	-
	12:35	B				
	12:53	B	No Compounds Detected	-	No	-
	13:10	C				
	13:28	C				
	13:45	D	No Compounds Detected	-	No	-
	14:04	E				
	14:20	F	No Compounds Detected	-	No	-
	14:40	G				
	15:00	A	No Compounds Detected	-	Yes	Wet diaper, urine/ porta potty odour
	15:18	A

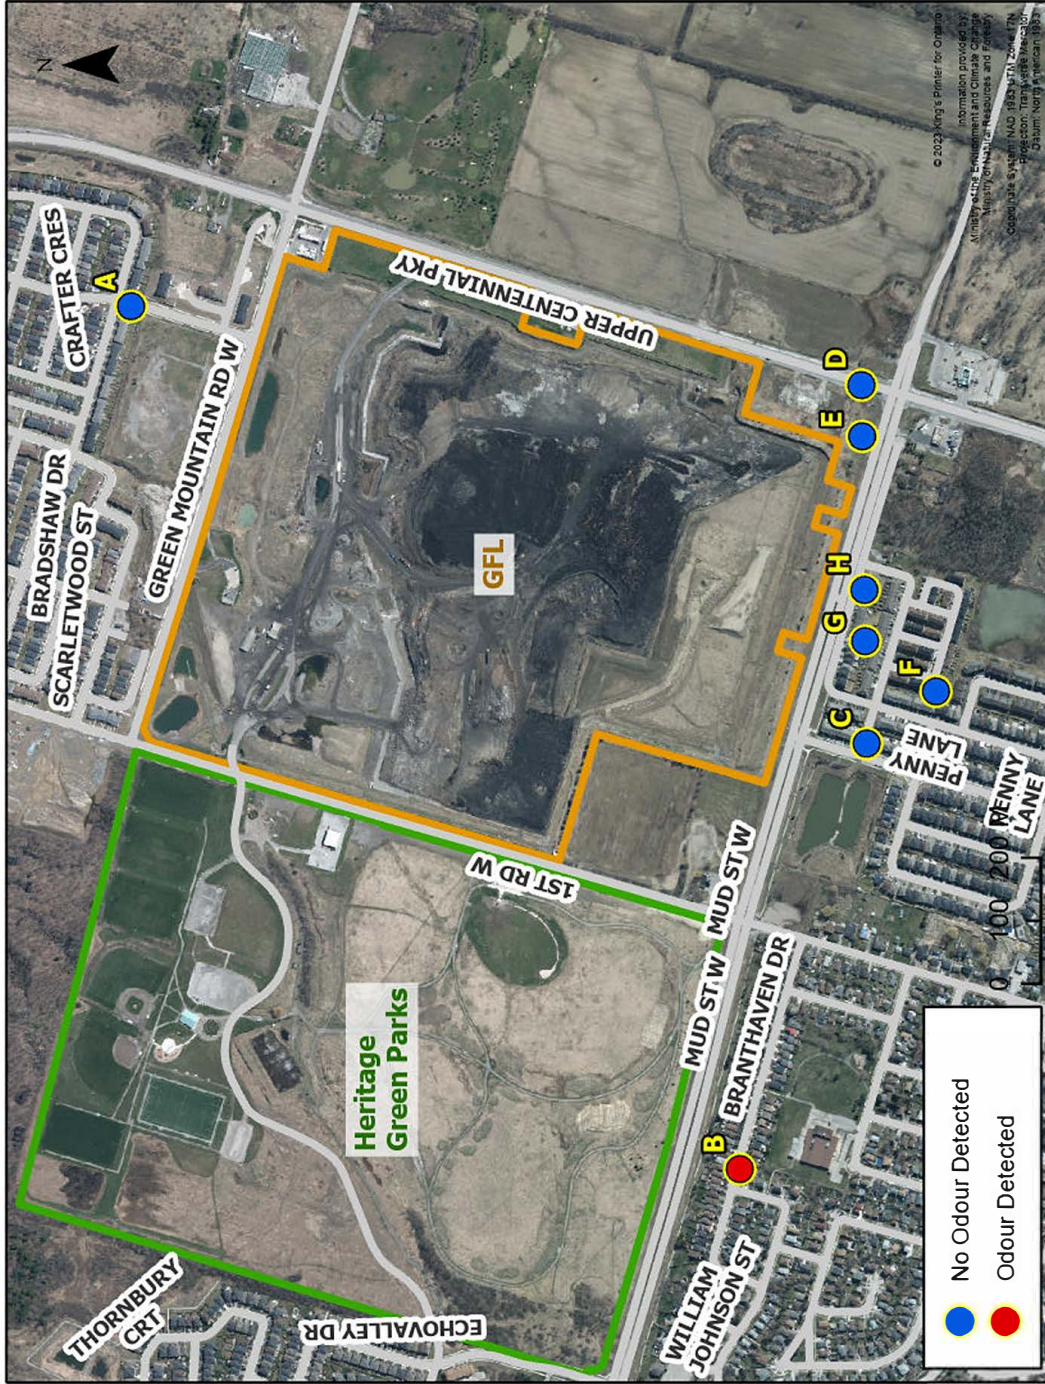
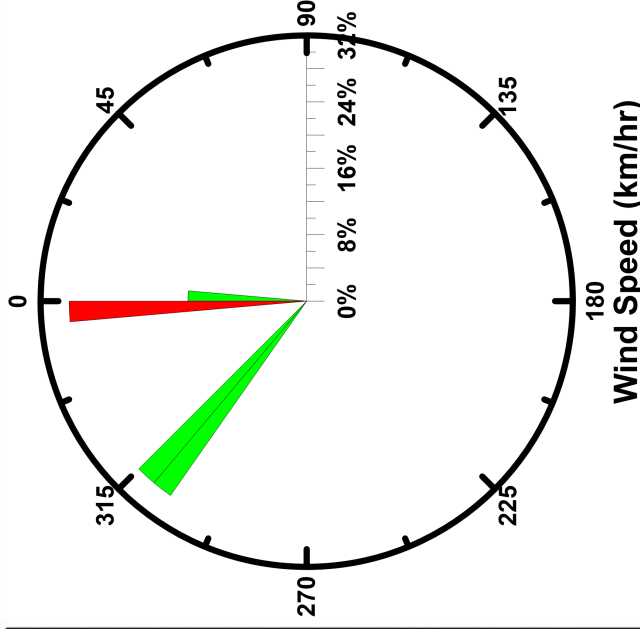
HAPSITE compounds and other compounds were not detected on this sampling day. Garbage, leachate, musty and natural gas odours were detected by the technician at a single location south where the leachate pond was upwind and a probable source. The odour could not be quantified using the nasal ranger ($D/T < 2$). Odours were not detected at other samples south of the GFL Facility. Winds were generally blowing from the north and northwest where the Facility was upwind.

Date	Time (Location)	Name	HAPSITE Comments:	Other compounds (PM, H ₂ S, Nox, CO or SO ₂)	Odours observations	General Comments
25-Aug-23	10:38	A	No Compounds Detected	-	No	-
	10:50	A	No Compounds Detected	-	-	-
	11:13	B	No Compounds Detected	-	Yes	Garbage, Leachate, Musty, Natural Gas Odour. Overcast / muggy conditions with moderate wind speeds - 24C
	11:26	B	No Compounds Detected	-	No	-
	14:26	C	No Compounds Detected	-	-	-
	14:42	D	No Compounds Detected	-	-	-
	14:59	E	No Compounds Detected	-	-	-
	15:16	F	No Compounds Detected	-	-	-
15:43	G	No Compounds Detected	-	-	-	
15:49	H	No Compounds Detected	-	-	-	
16:05	H	No Compounds Detected	-	-	-

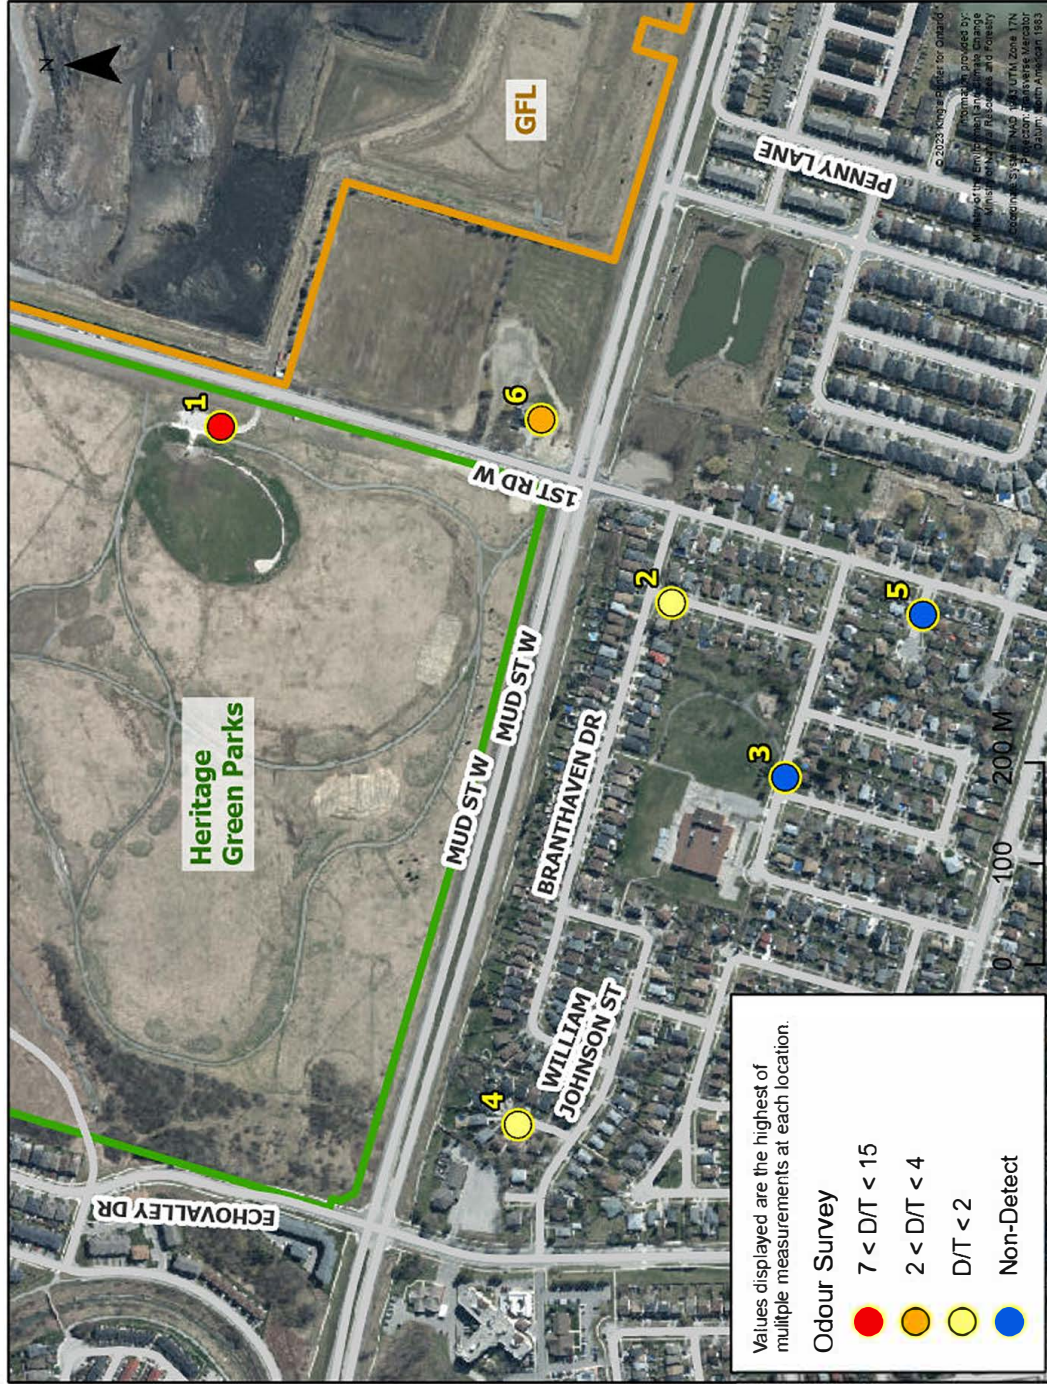
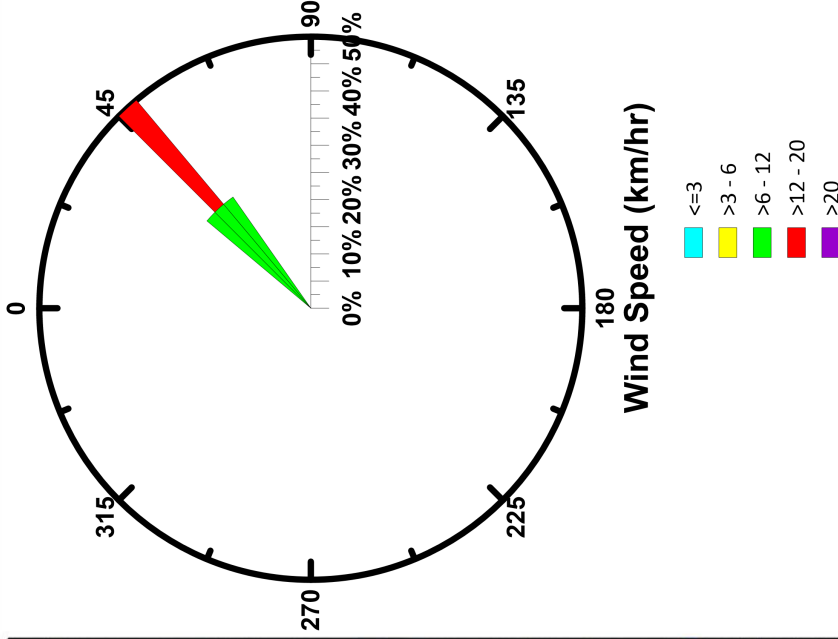
Figure 10 - GFL Environmental August 2023 Air Monitoring On-Site Assessment Survey - Aug 28, 2023

- Location 1 (dog park) - D/T ratios as high as $7 < D/T < 15$ were observed with odours that can be described as garbage, leachate, sweet, sour and sulphur smelling.
- Location 2 (Mellenby St.) – D/T ratios < 2 were observed with odours that can be described as garbage, leachate, sour and sulphur smelling
- Location 4 (Lemonyne Pl.) - D/T ratios < 2 were observed with odours that can be described as garbage and sour smelling
- Location 6 (Model Home Parking Lot) - D/T ratios up to $2 < D/T < 4$ were detected with odours that can be described as garbage, sour, leachate smelling.

Date	Time (Location)	Name	HAPSITE Comments:	Other compounds (PM, H ₂ S, Nox, CO or SO ₂)	Odours observations	General Comments
28-Aug-23	12:33	1	Toluene: 8.7 ug/m ³	Slightly elevated H ₂ S	Yes	Odour Survey Conducted. Odours detected.
	12:55		1-3-dimethylbenzene: 3.6 ug/m ³		Yes	
	13:12		No Compounds Detected		Yes	
	13:28	2	No Compounds Detected	-	No	
	13:47		No Compounds Detected		Yes	
	14:05		No Compounds Detected		No	
14:22	3	No Compounds Detected	-	Yes		
14:47		No Compounds Detected		No		
15:03		No Compounds Detected		Yes

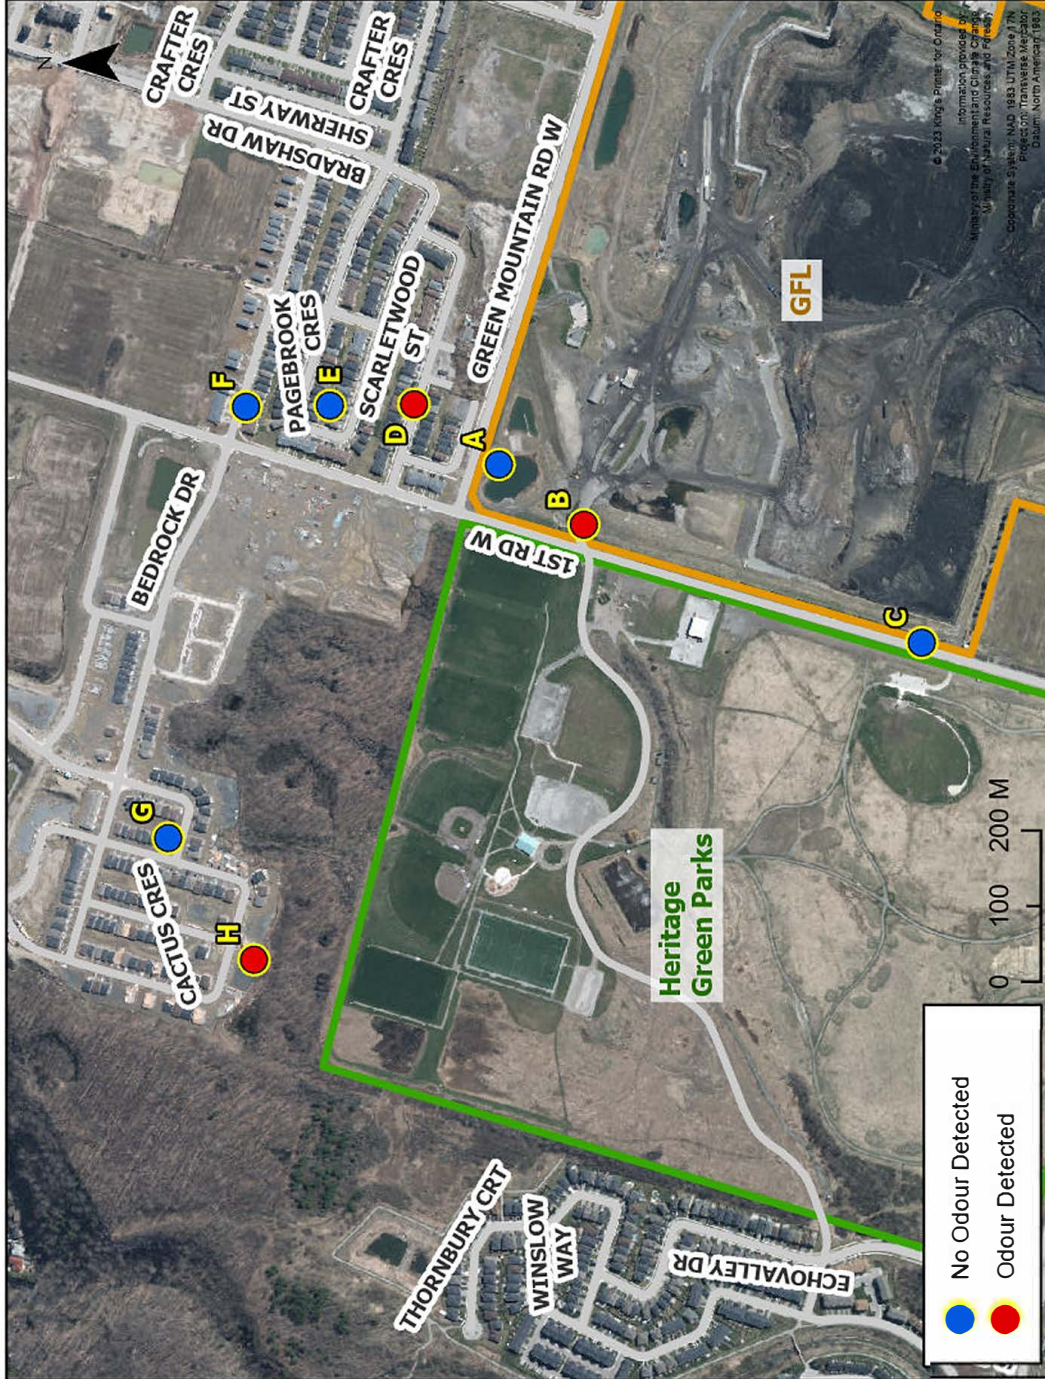
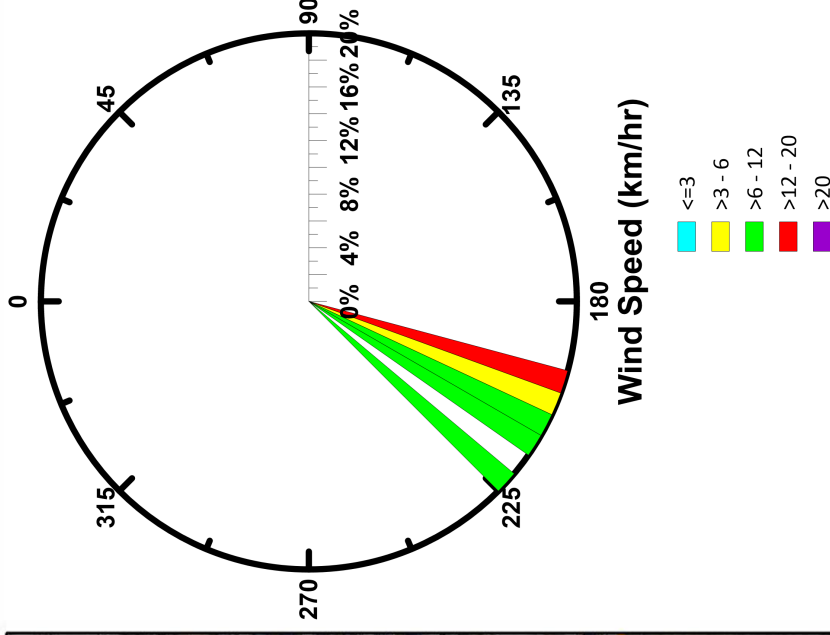
Figure 11 - GFL Environmental August 2023 Air Monitoring On-Site Assessment Survey - Aug 29, 2023

HAPSITE compounds and other compounds were not detected on this sampling day. Sweet, sour and garbage odours were detected by the technician while onsite from various locations. The odours could not be quantified using the nasal ranger ($D/T < 2$). Winds were generally blowing from the southwest where the leachate pond was somewhat upwind and a potential odour source.

Date	Time (Location)	Name	HAPSITE Comments:	Other compounds (PM, H ₂ S, Nox, CO or SO ₂)	Odours observations	General Comments	
29-Aug-23	11:40	A	No Compounds Detected	-	No	-	
	12:00	B	No Compounds Detected	-	Yes	Sweet & Sour	
	12:15	C	No Compounds Detected	-	No	-	
	12:30	D	No Compounds Detected	-	Yes	Sweet & Sour	
	12:50	E	No Compounds Detected	-	No	-	
	13:15	F	No Compounds Detected	-	No	-	
	13:40	G	No Compounds Detected	-	Yes	Sweet & Sour	
	13:57	H	No Compounds Detected	-	No	-	
	14:13						
	14:30			No Compounds Detected	-	Yes	Garbage
