City of Hamilton

# Roadside Safety Assessment

Red Hill Valley Parkway

Final Report  
January 2019

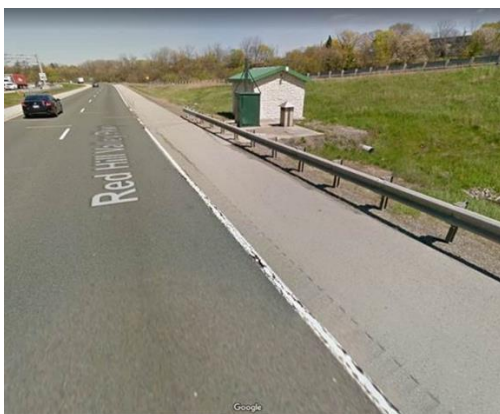
Figure 32: HCS07B near Queenston Road

The City requested a review of the potential to improve access to two wastewater facilities located off the Red Hill Valley Parkway: HCS07B, located on the east side of the Red Hill Valley Parkway, approximately 200 m north of Queenston Road (**Figure 32**); and HCS07C, also located on the east side east of the Red Hill Valley Parkway, approximately 400 m north of Barton Street (**Figure 33**).

City staff visit these sites monthly, when the operator drives past the station and pulls off to the gravel shoulder of the road. They then reverse against the flow of traffic and park behind guardrail/barriers for protection. The City is considering widening and extending the gravel portion of the shoulder to allow the service vehicle to better manoeuvre and park safely behind the guide rail, preferably from the south side to avoid reversing.
